# Larrawa station—producer demonstration site

Photo story of works completed November 2011

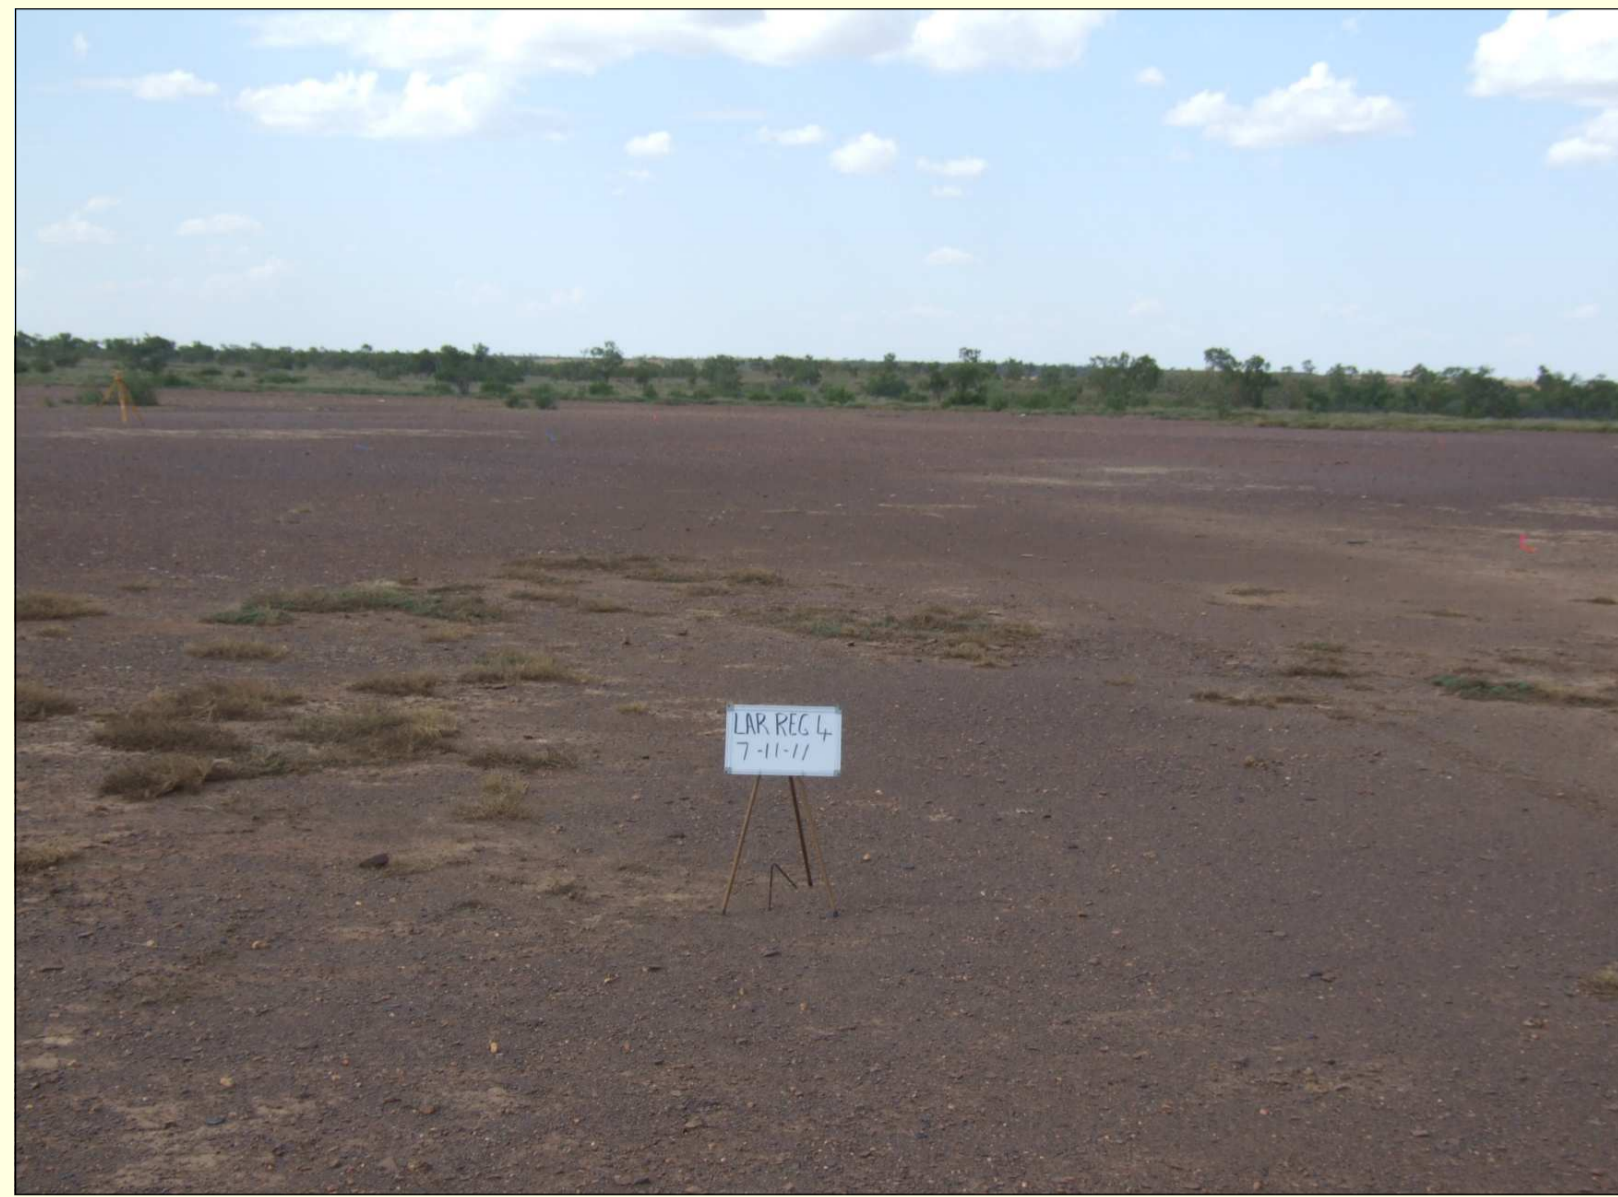
Photo 1. Larrawa station regeneration monitoring site no.4 (pre works).

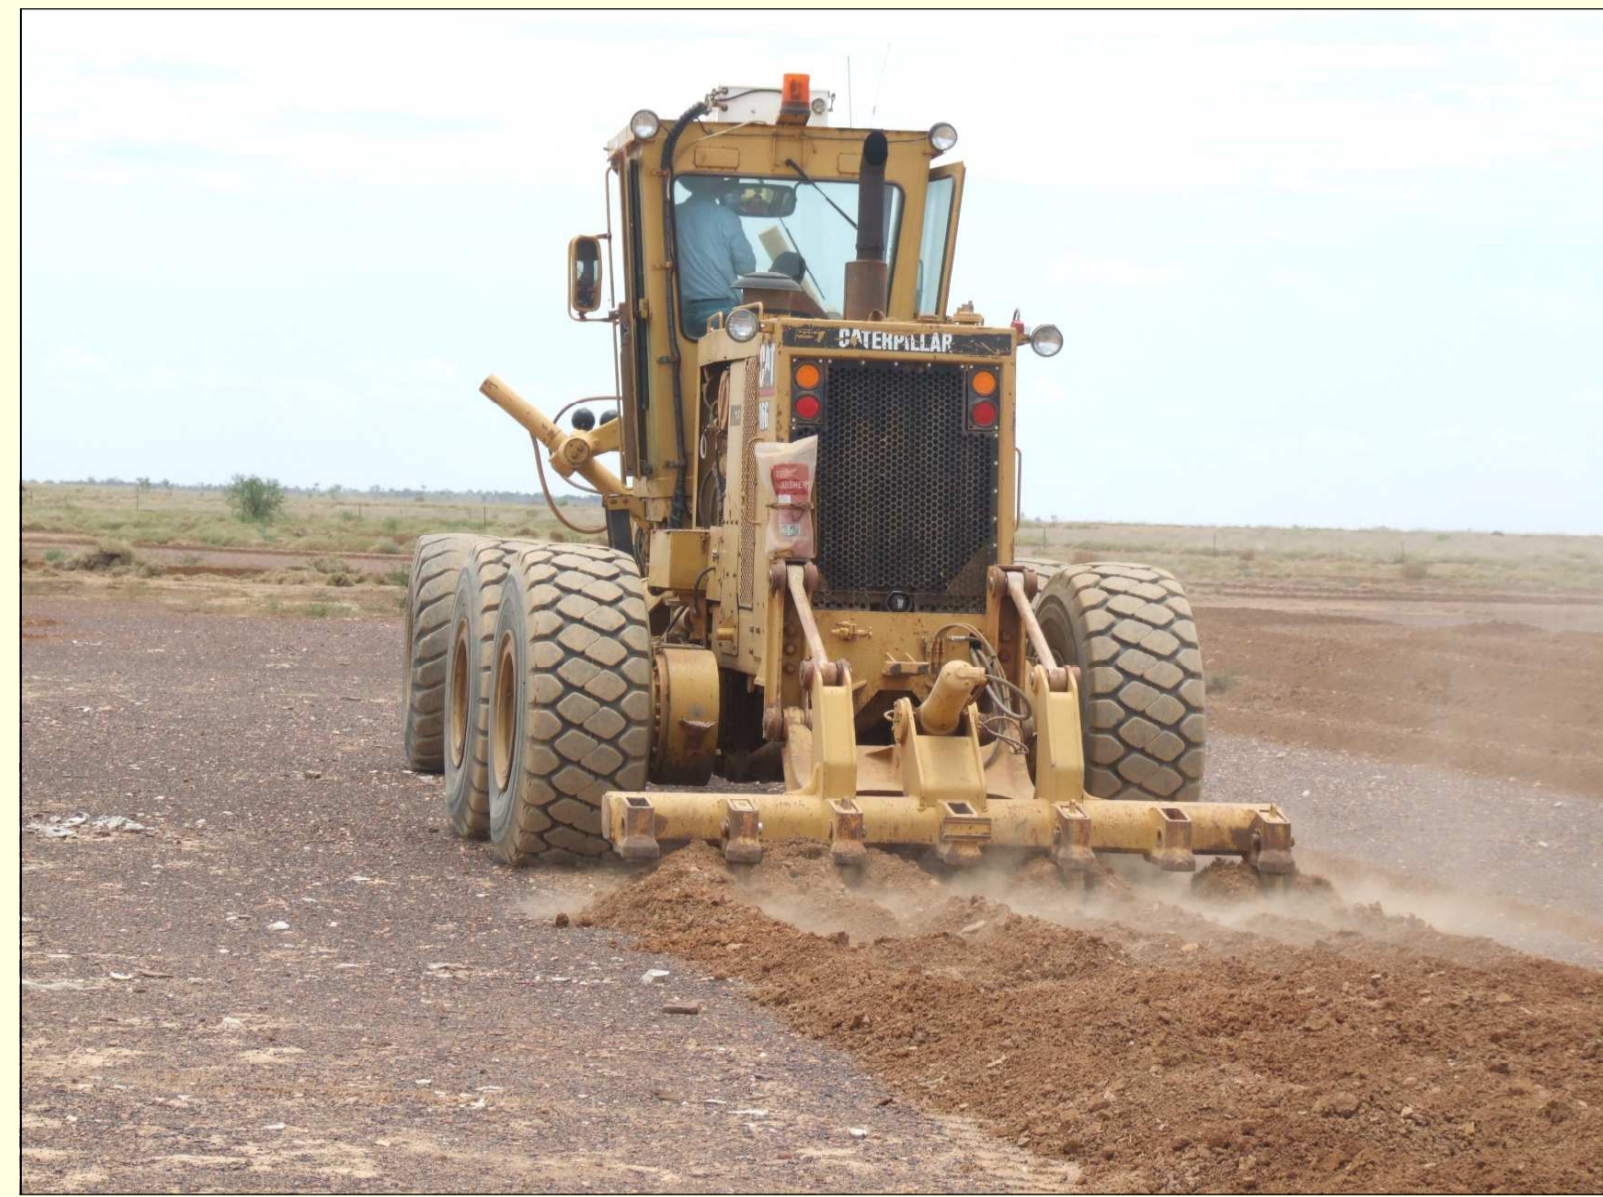
Photo 2. Ripping before bank construction with 16G grader.

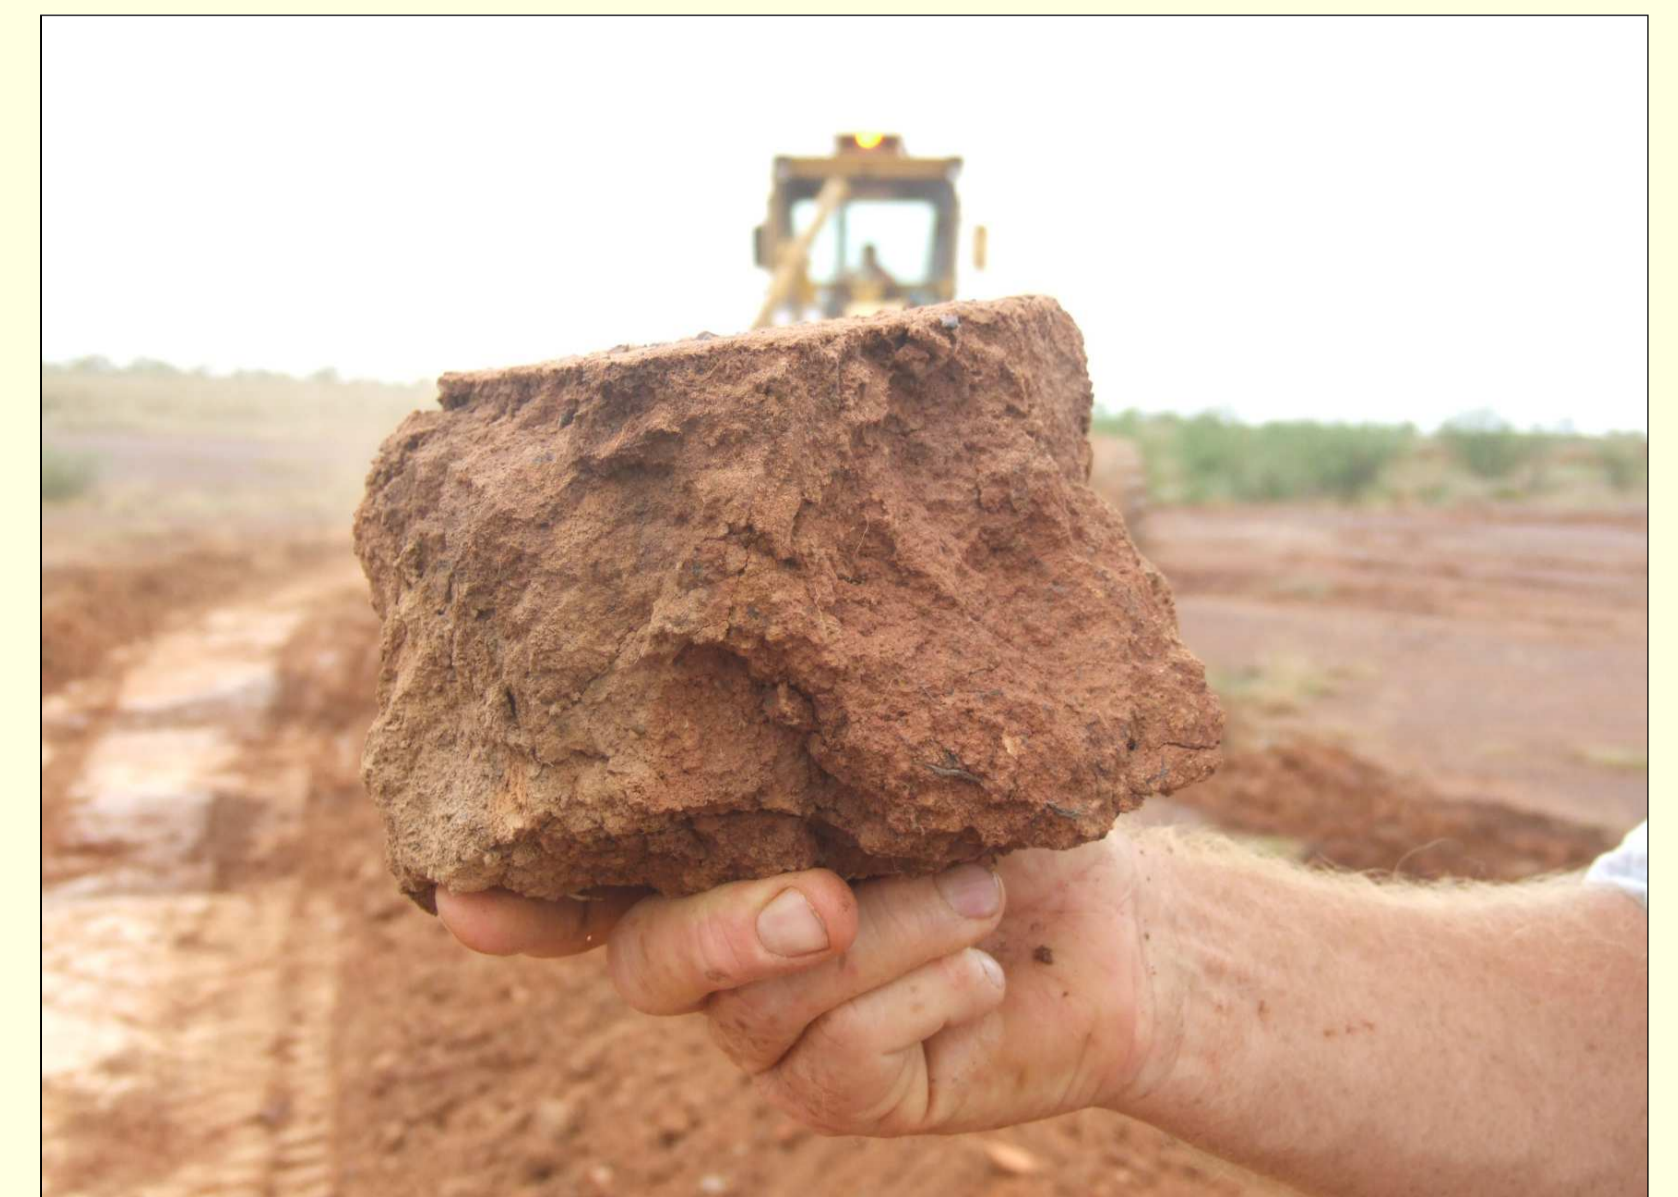
Photo 3. Soil crust post ripping.

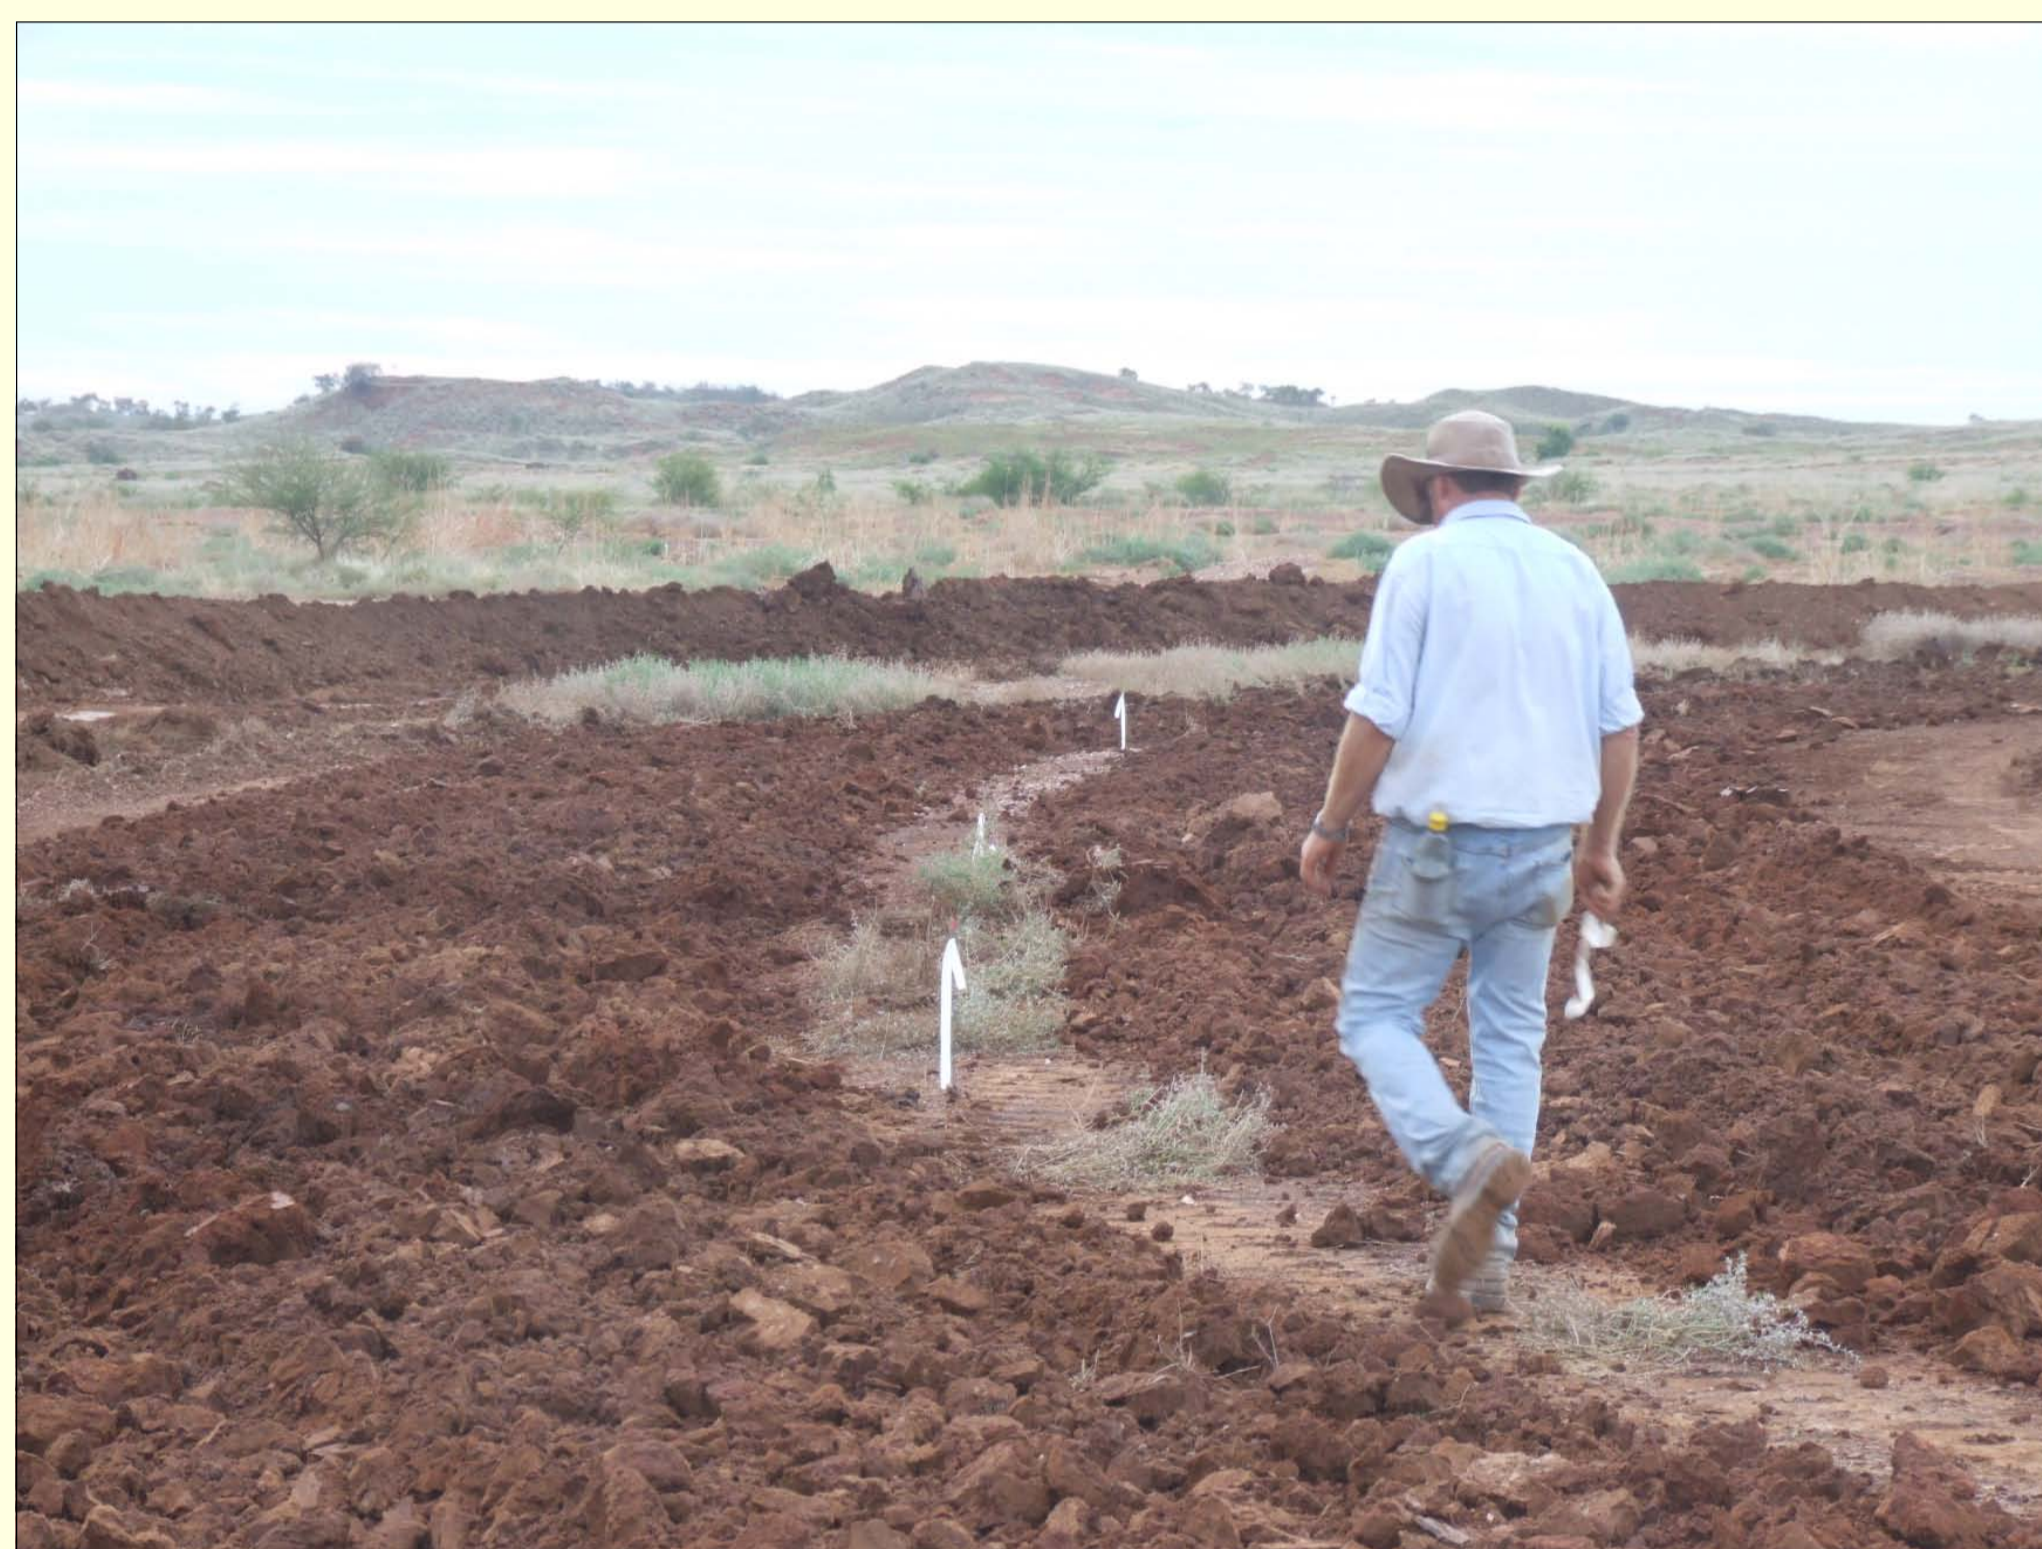
Photo 4. Collecting markers between rip lines before building bank. The non-ripped area between rip lines will form the bank base.

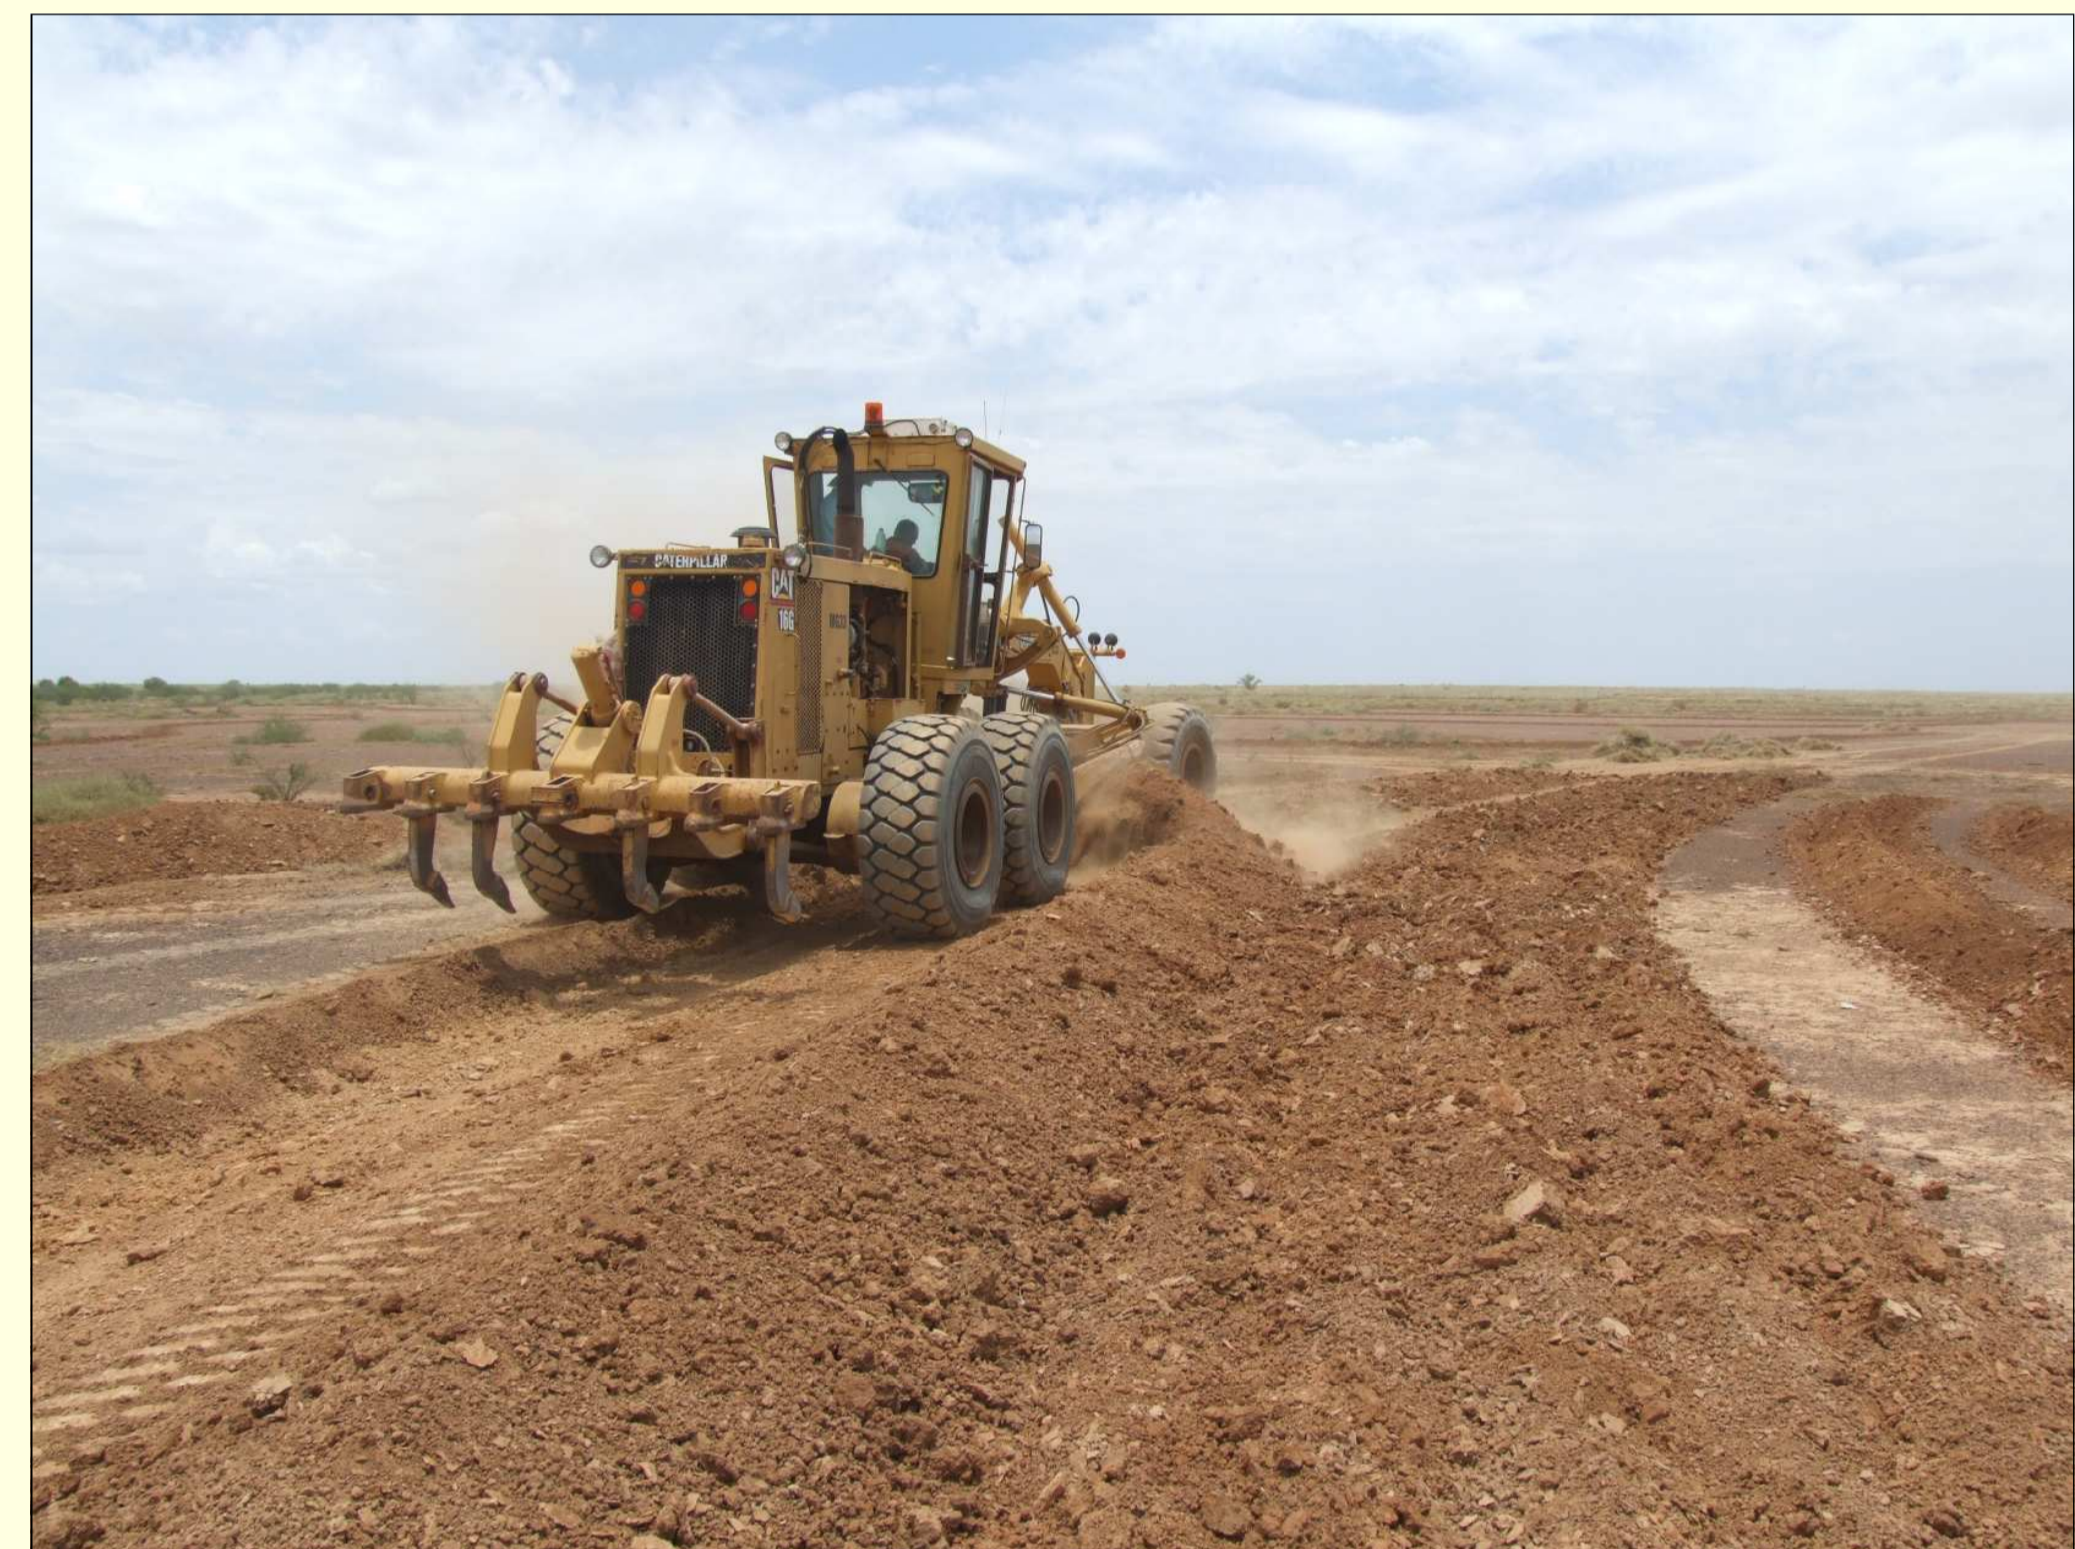
Photo 5. Taking first blade of soil to form bank, starting on outside of pond.

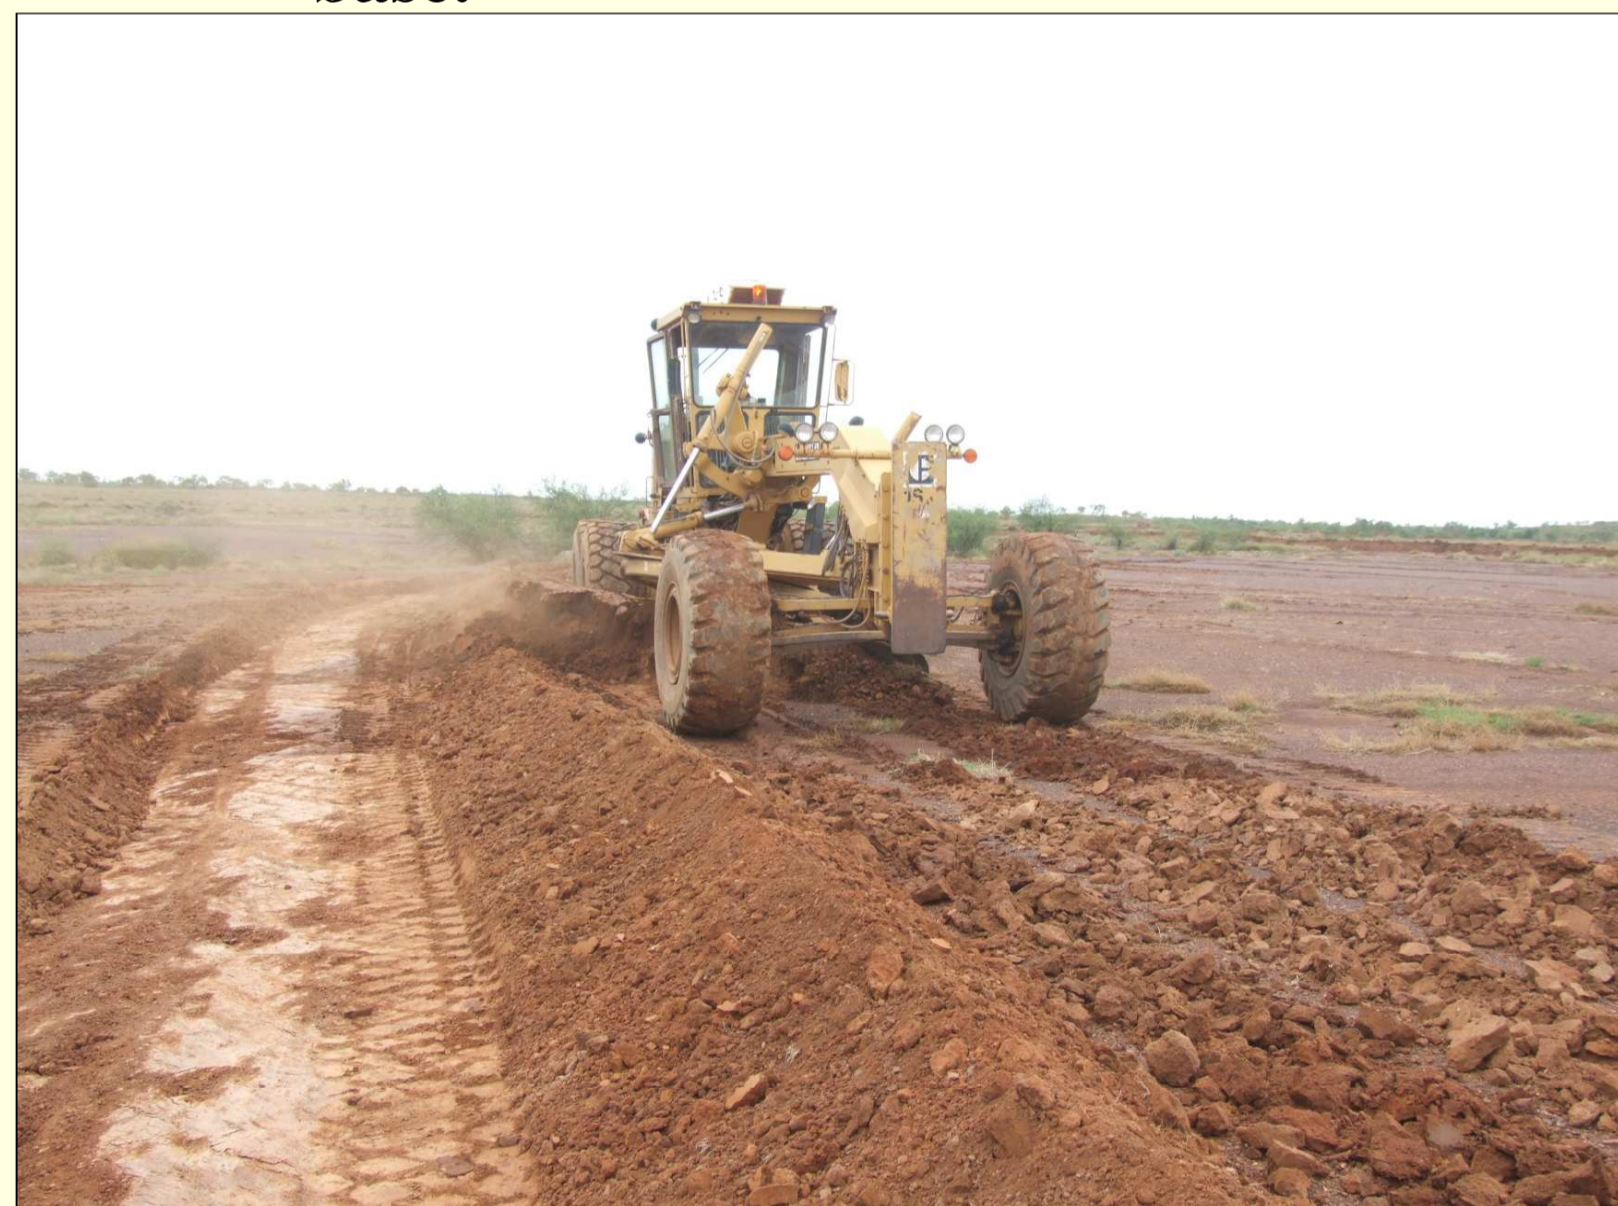
Photo 6. Taking second blade of soil (rolling onto existing bank) on inside of pond.

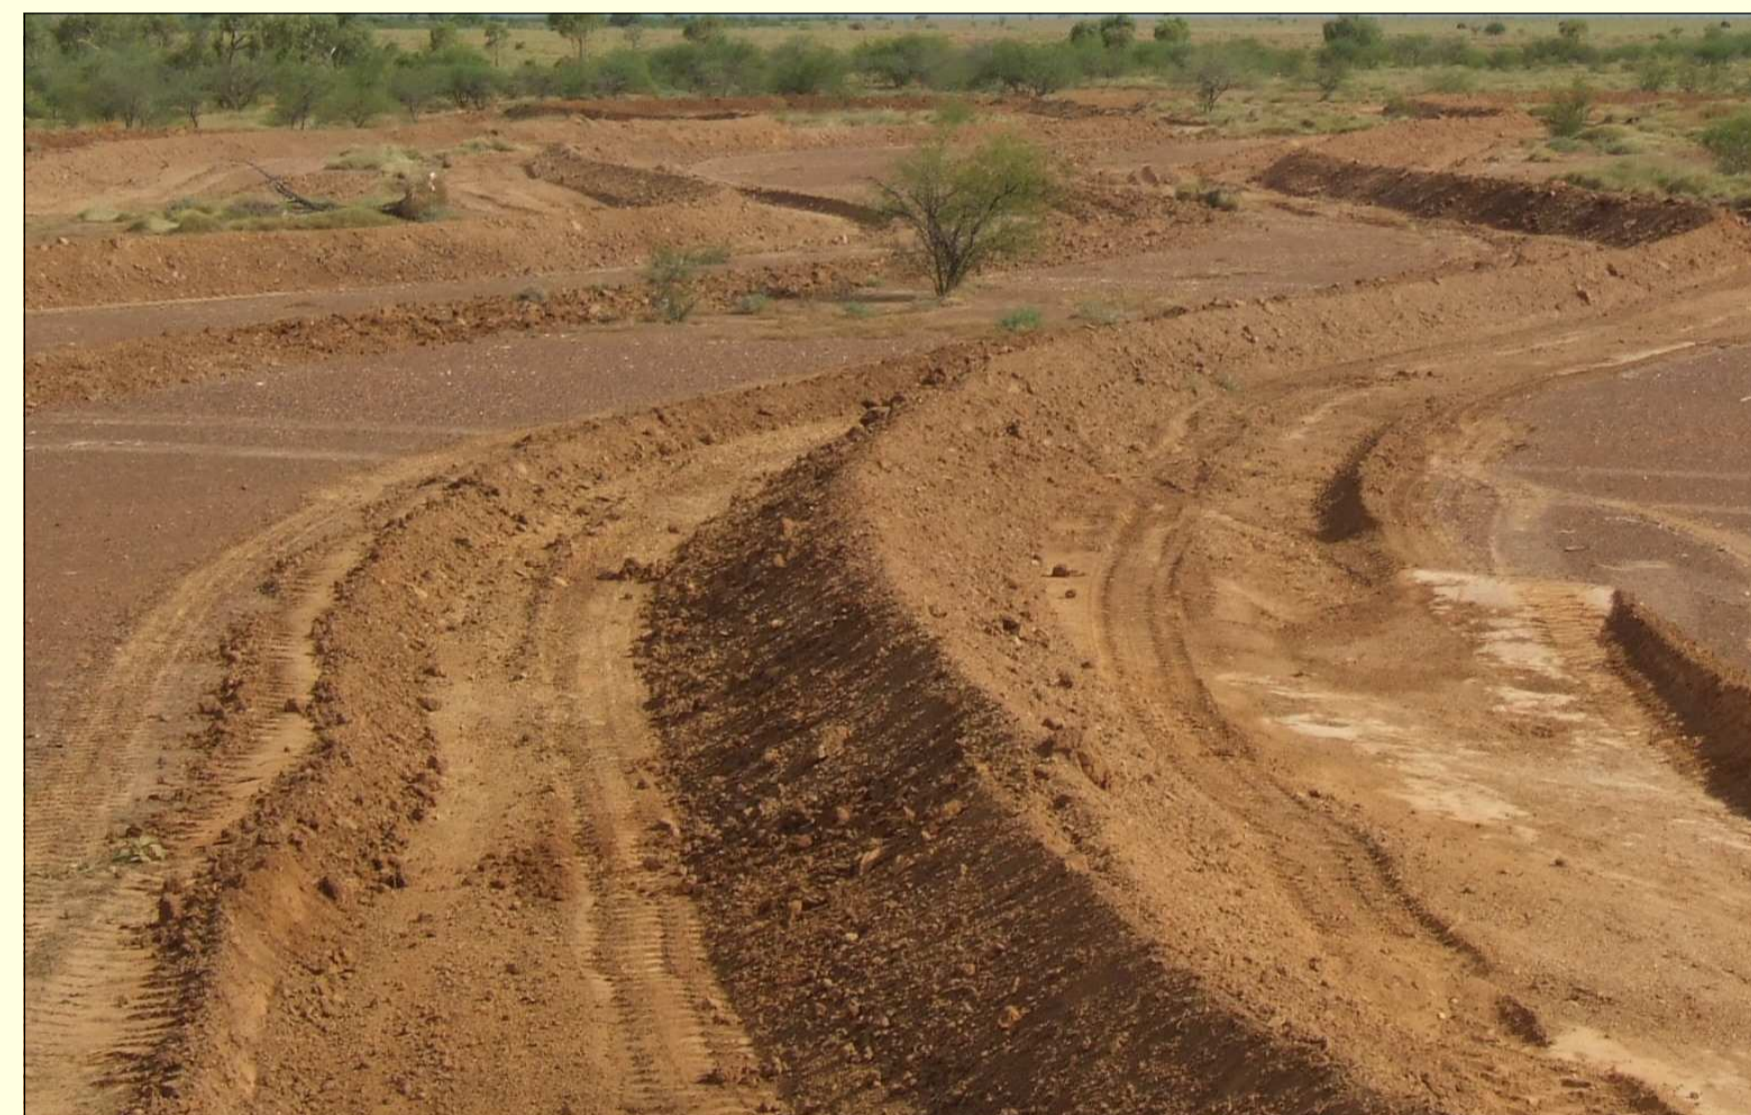
Photo 7. Completed bank. The domed top will allow rainfall to flow away, minimising pooling on bank top.

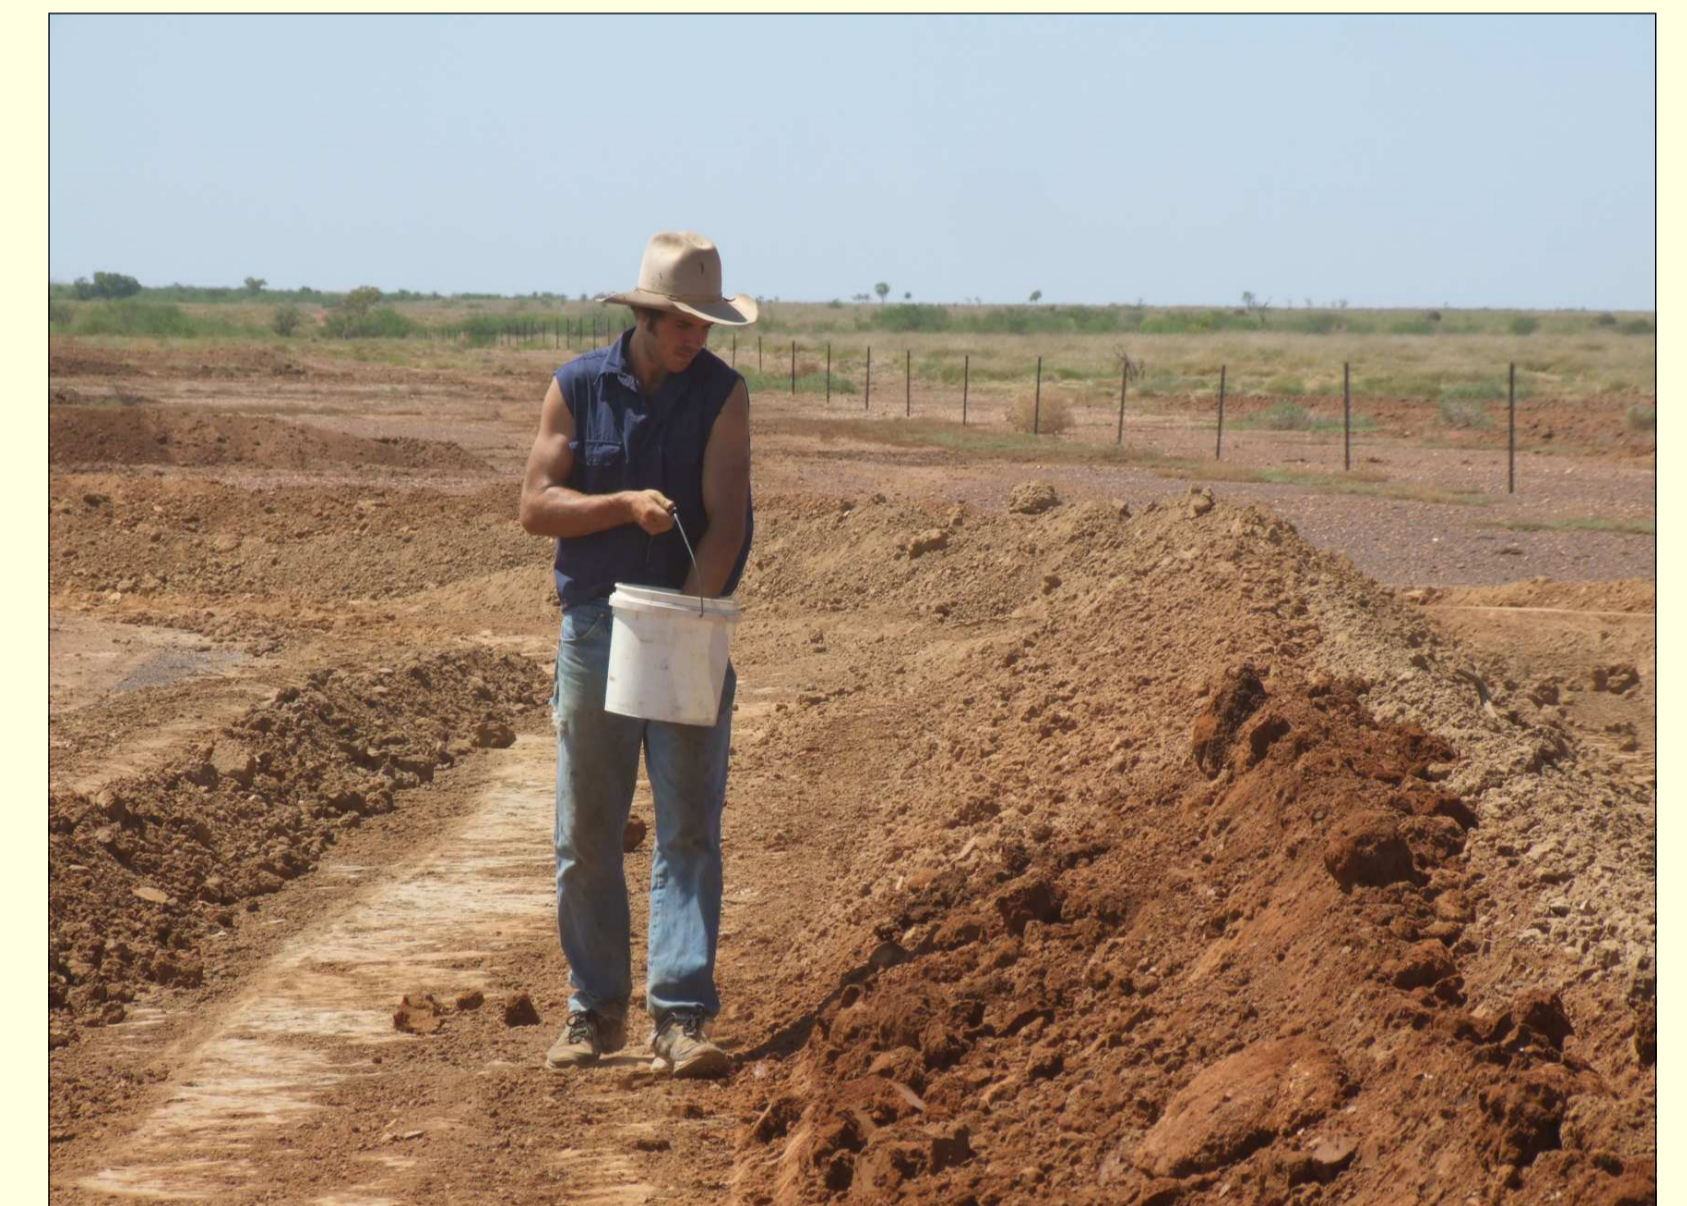
Photo 8. Casting forage sorghum on inside of bank to ensure germinable seed is present.

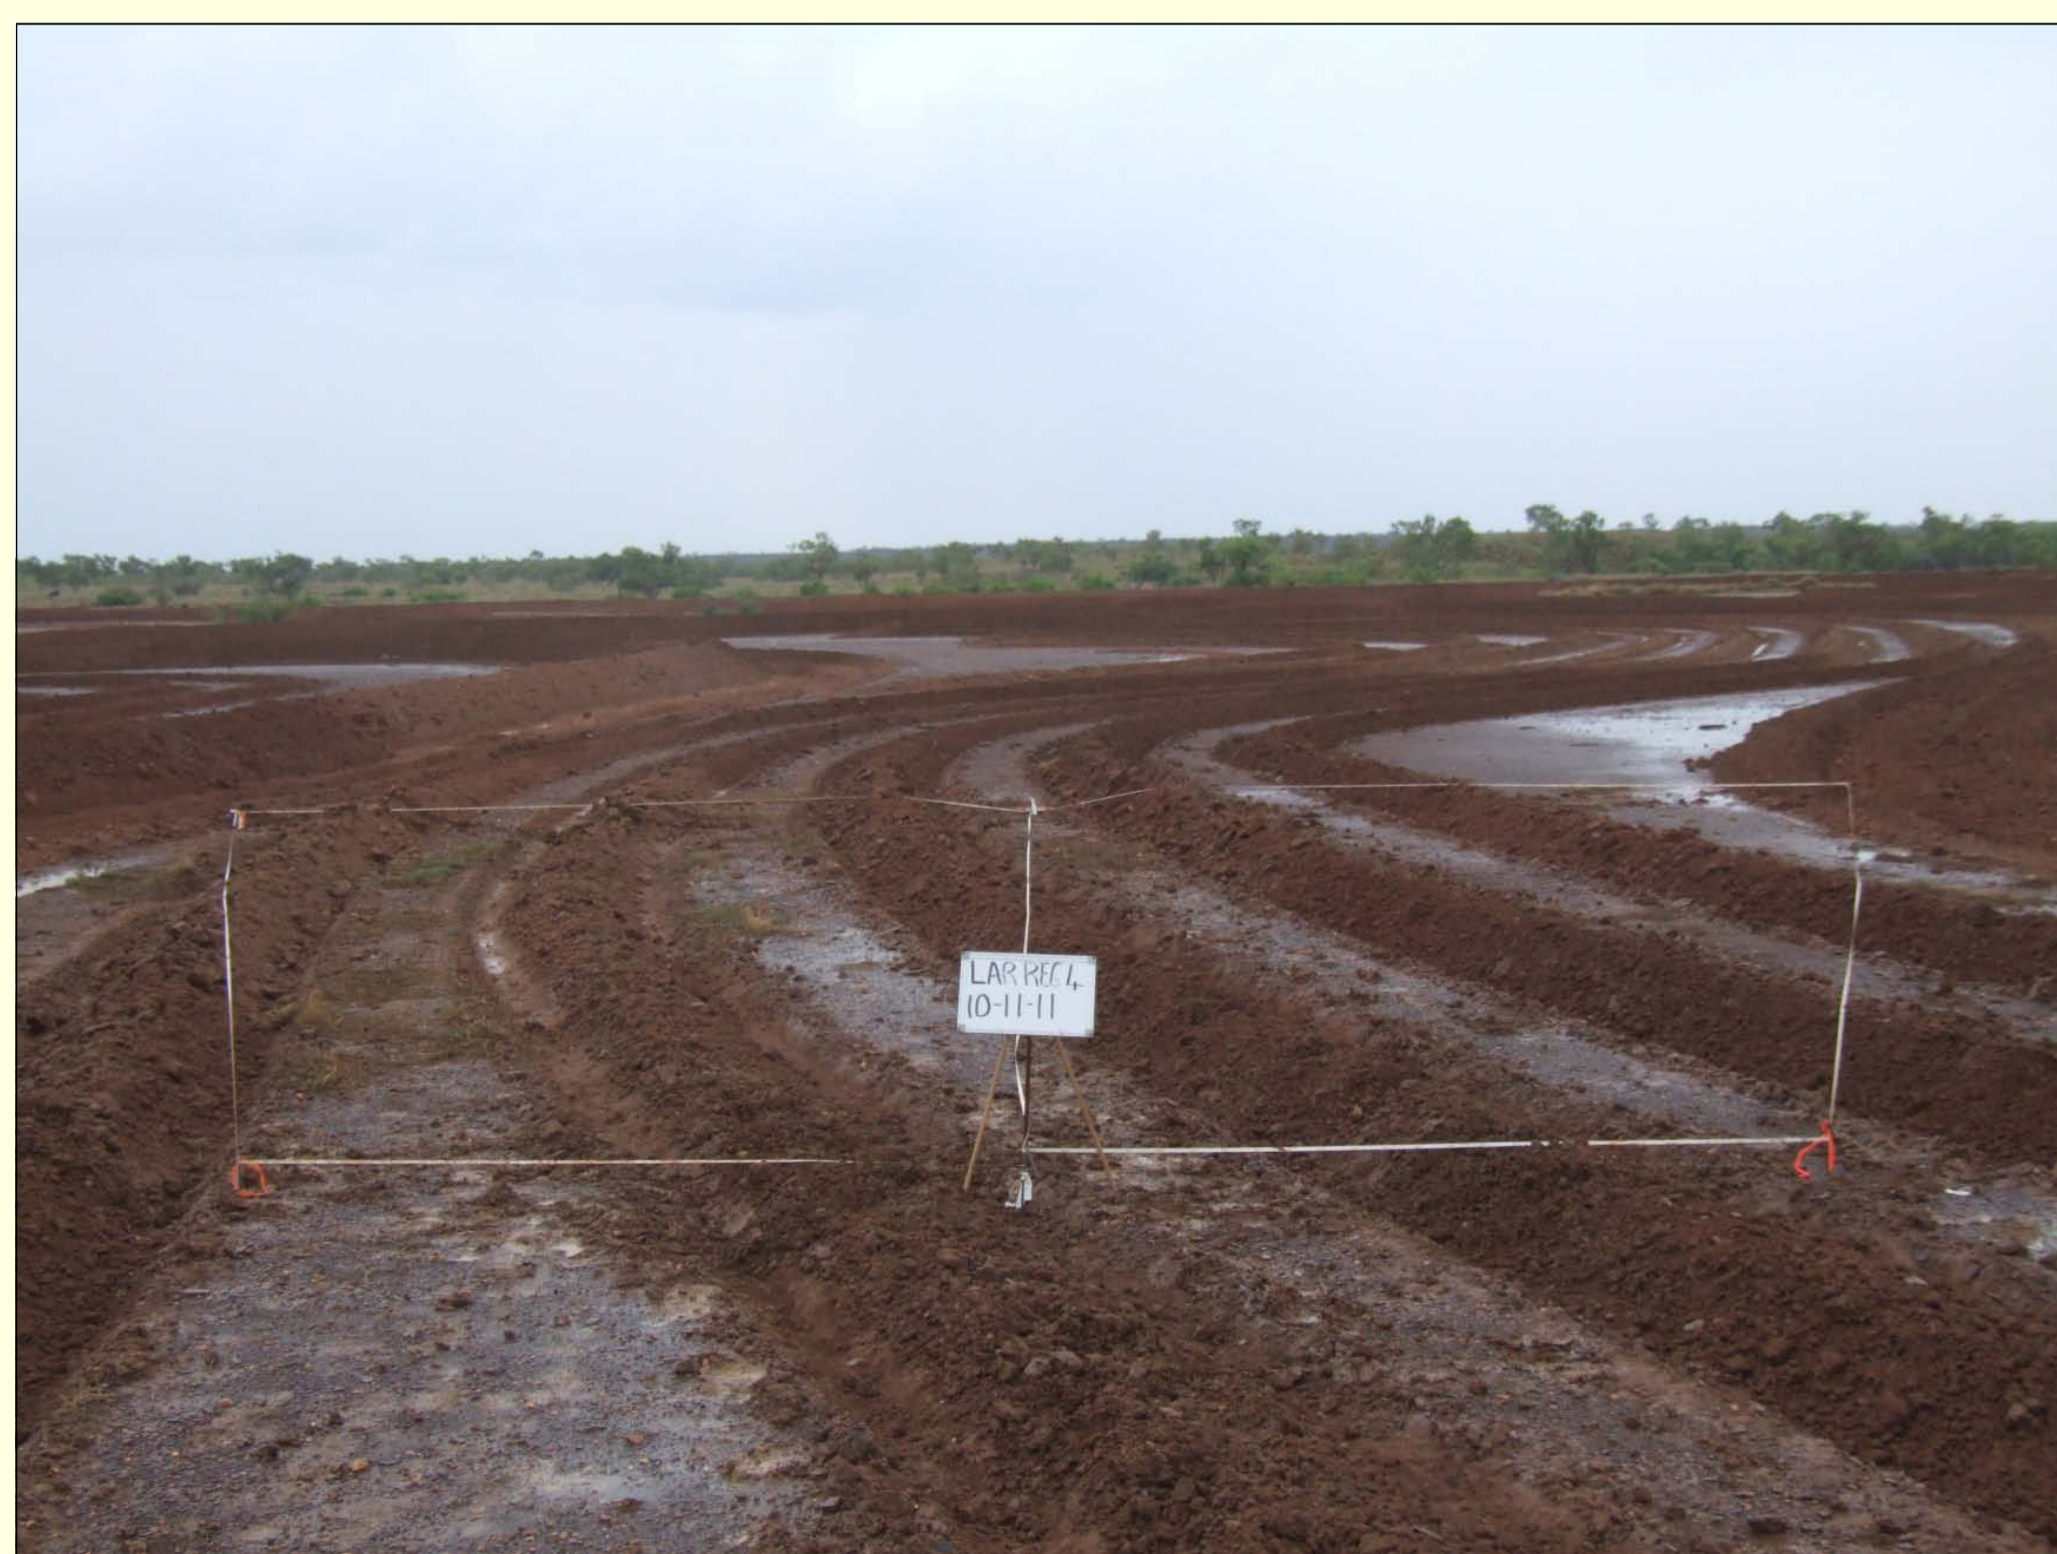
Photo 9. Larrawa station regeneration monitoring site no.4 (post works).
