# Larrawa station—producer demonstration site

Photo story of works completed November 2011

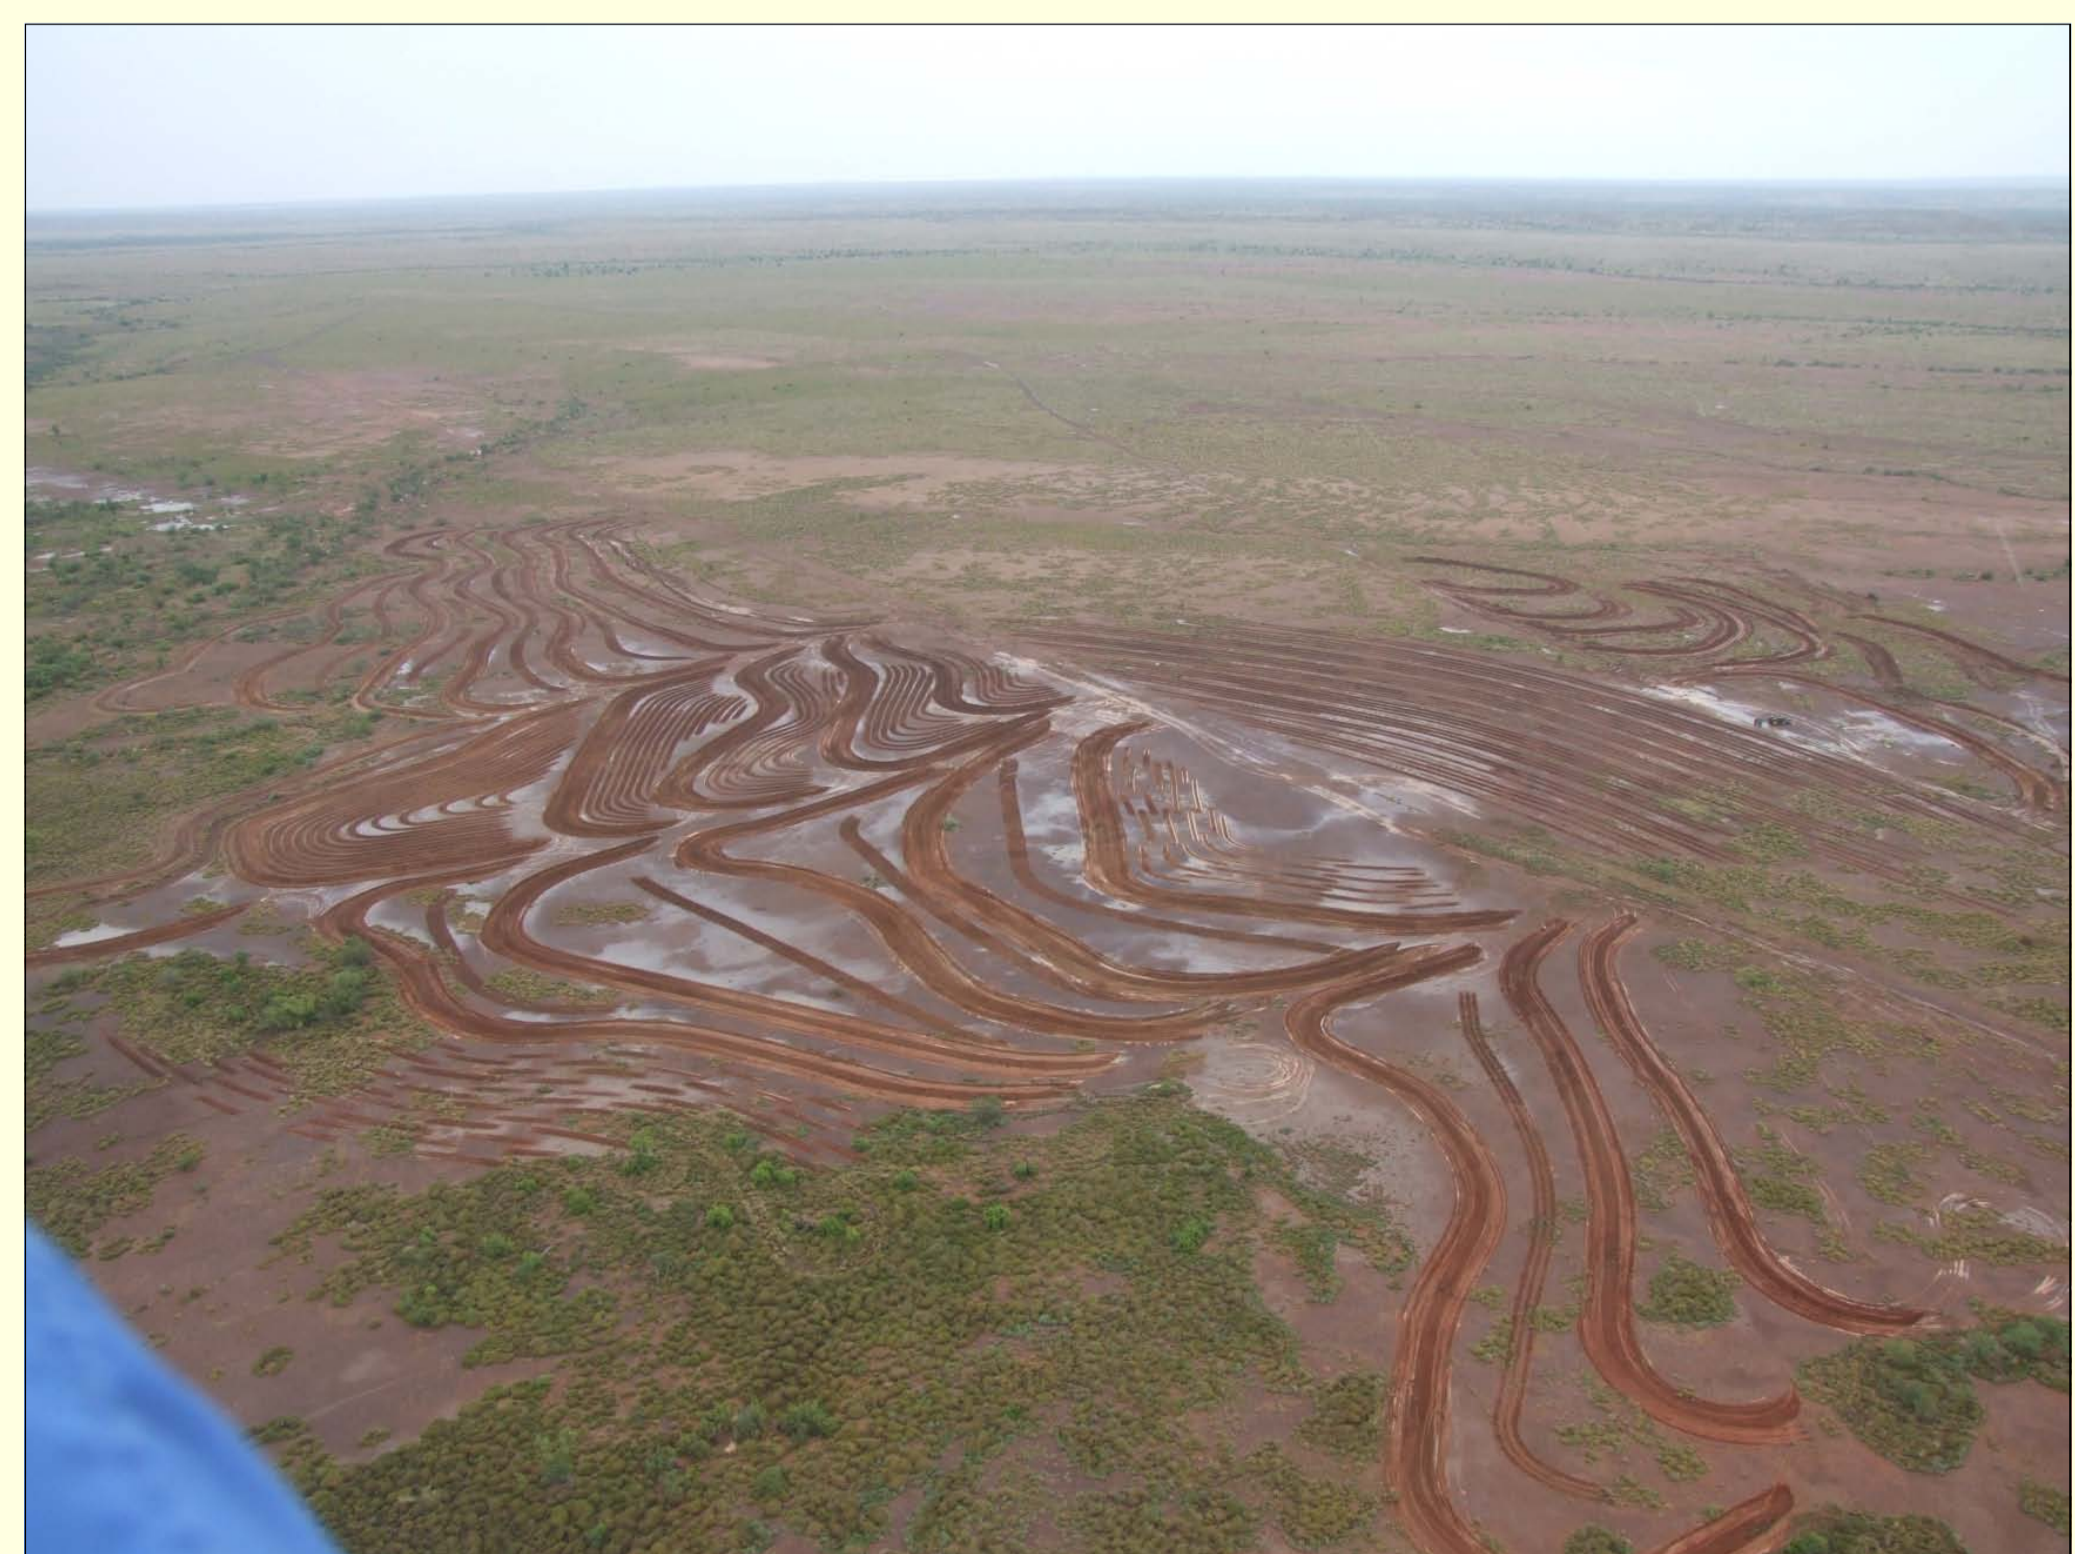
Photo 10. Aerial shot of regeneration area.
