GrazingFutures LBR Case Study

Cubbaroo Station — Addressing erosion issues in the Southern Gulf after dry years and a 1-in-100-year flood

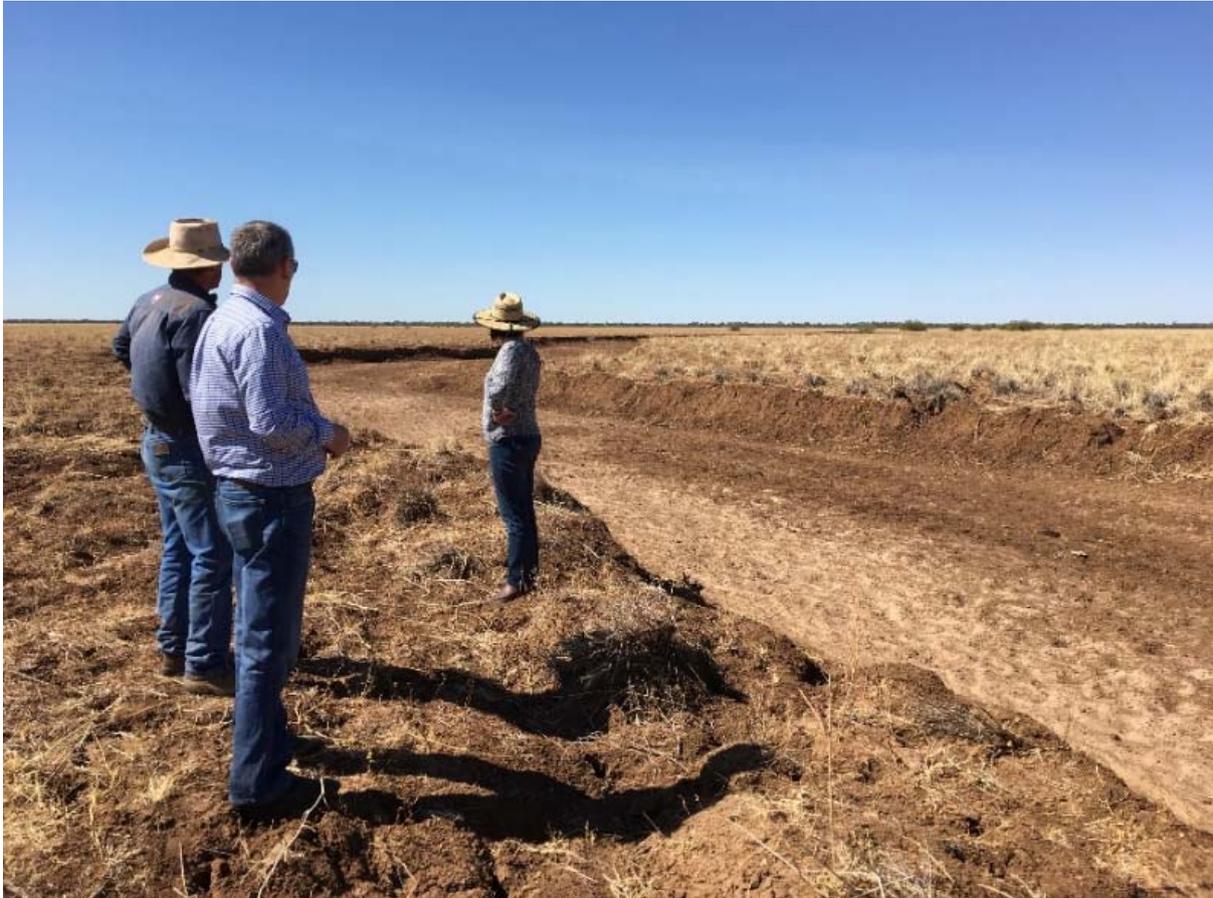
North QLD Livestock Recovery Agency staff visit the erosion site at Cubbaroo in June 2019. The proliferating gully that was formed from an old cattle pad stems across 55 hectares but has had a direct effect on the land condition of 168 hectares.

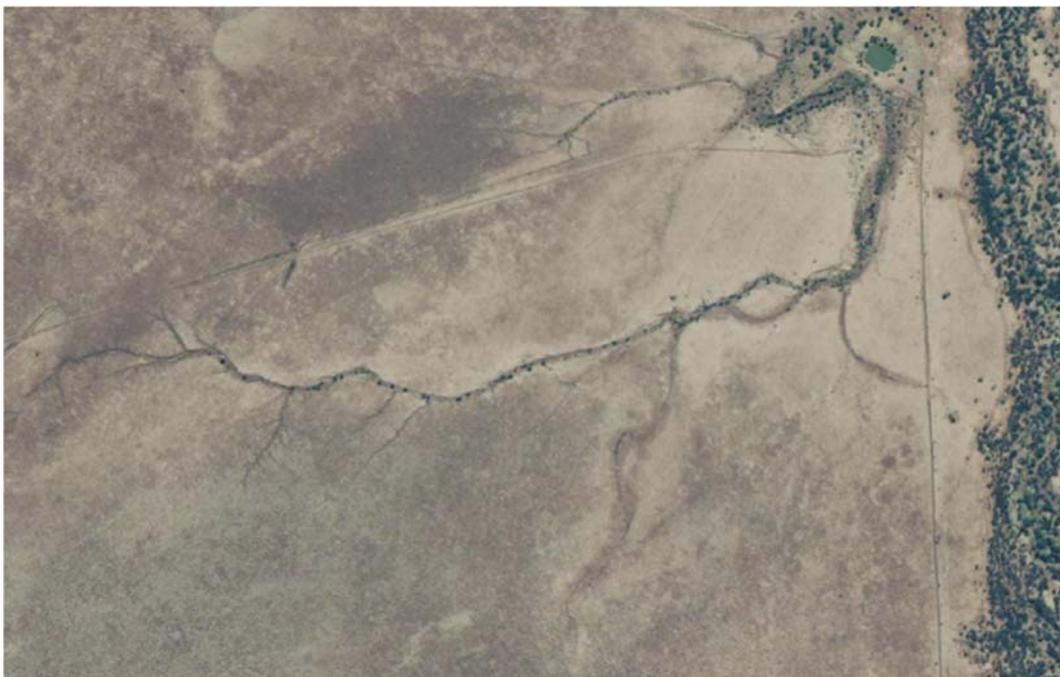
The erosion site from above, prior to remediation works. The main channel is 2km+ in length, and directly affects approximately 168ha of the 2590ha paddock. Source: QLD Globe

Based on figures from [Best-bet practices for managing the Mitchell grasslands of Queensland](#) written by David Phelps (DAF), the affected eroded area that had declined to a land condition of D, was now rated at 25% of its long-term carrying capacity, and pasture growth and response to rain had been reduced by 75%.

Climate modelling has predicted weather and climate events in north west Queensland, such as rain or heatwaves, to trend towards 'more extreme' in years to come. With this in mind, without intervention, the eroded gully could potentially double in size over the next 10 years (13% of the 2590-hectare paddock).

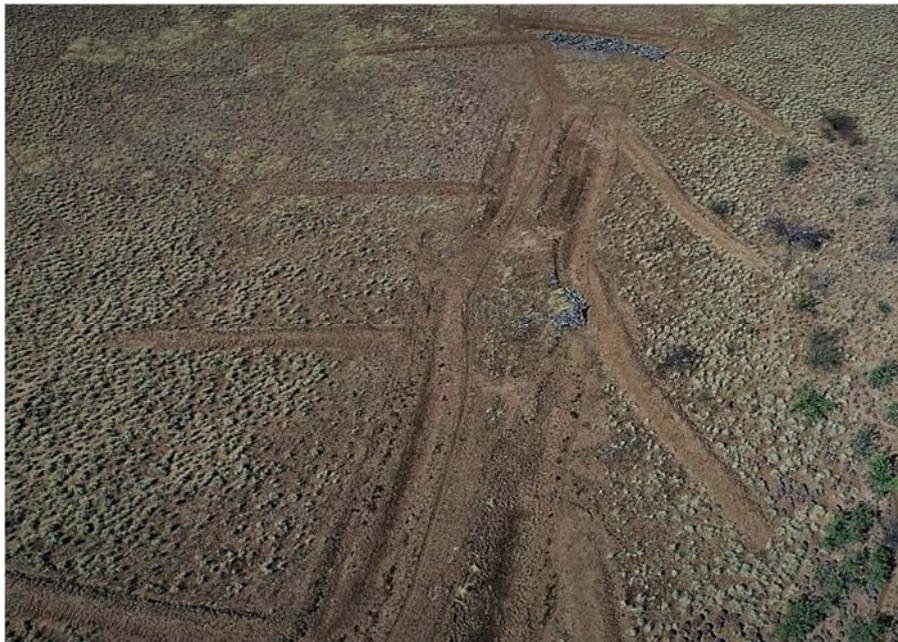
*Contour
long flat bottom drains (September 2021)*

banks with

The next step was to plan and peg out start and finish points for the contour banks and construct them with the scraper. Contour banks, also known as check banks or bunds, are low earthen banks used for diverting and collecting moving water. The soil for the contour bank is taken from the flat bottom, wide drain that is created at the lower end of the contour bank, pooling and taking the energy out of fast-moving water. The water then spreads out onto the landscape at a much slower pace than what it entered.

“Next time I will use a dumpy level to plan the contour banks to make sure they are aligned with the natural flow direction. After the check banks and flat bottoms drains were built, Darryl came back to Cubbaroo, and we surveyed the banks using a dumpy level. We were spot on with most of them, but a few needed some adjustments”.

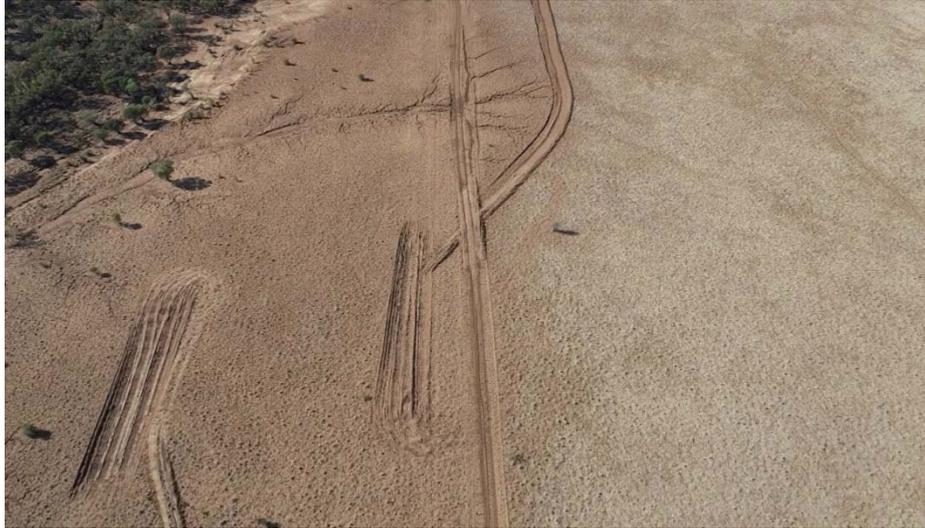
October

2020 -

Branches of erosion coming out of the main channel towards a road. A levy bank redirects the water from flowing down the gullies and making the erosion worse. Once the water flows into the flat bottom drain, it pools, settles and seeps slowly out of the drain back onto the natural flow direction. The land colour change on either side of the road indicates lack of ground cover of the eroded land in comparison to unaffected soils.

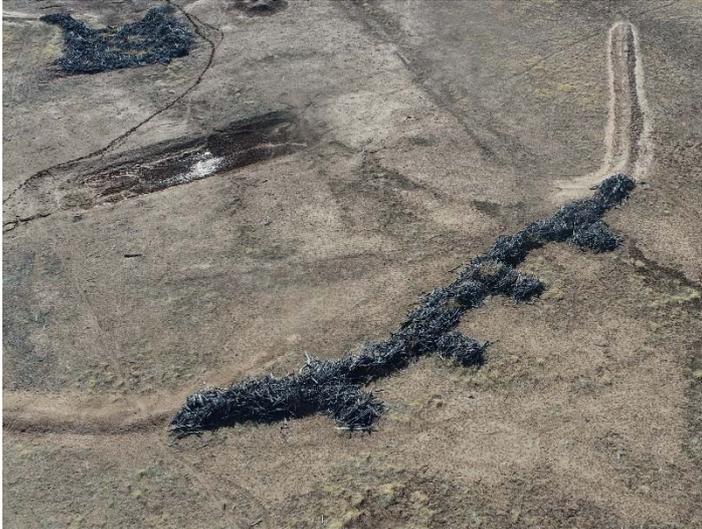
September 2021 - One of the natural leaky barriers

'Bush filters', or 'beaver walls' as the Halcons' labeled them, were next in the pipeline for the erosion site. These bush filters consisted of piles of Gidyea logs placed across the main gully, that act as a leaky barrier, slowing water down for a prolonged period but not blocking it up all together. As the water flows through, sediment gets trapped on the top side of the logs and builds up, slowly filling in behind the log pile – natural remediation of erosion at its finest! Piles of stick raked Gidyea logs were carted from paddocks to the erosion site via two hired tip trucks. The Cubbaroo team had engineered a set of forks that attached to the loader bucket to pick up piles of logs. At each site where log piles were placed across the erosion site, the loader dug out a small pit for the log piles to sit in, as an extra measure to slow the water down and reduce erosion by creating an area for fast water to pool in, slow down and then seep downstream.

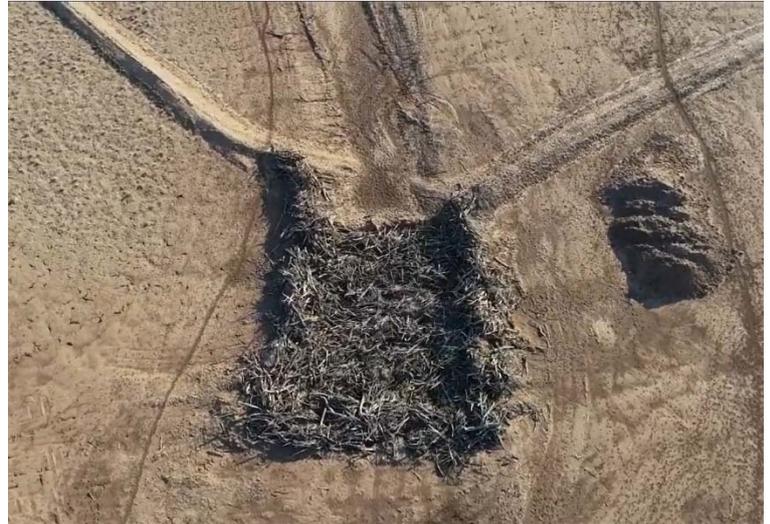
October 2020 – Another leaky barrier further upstream

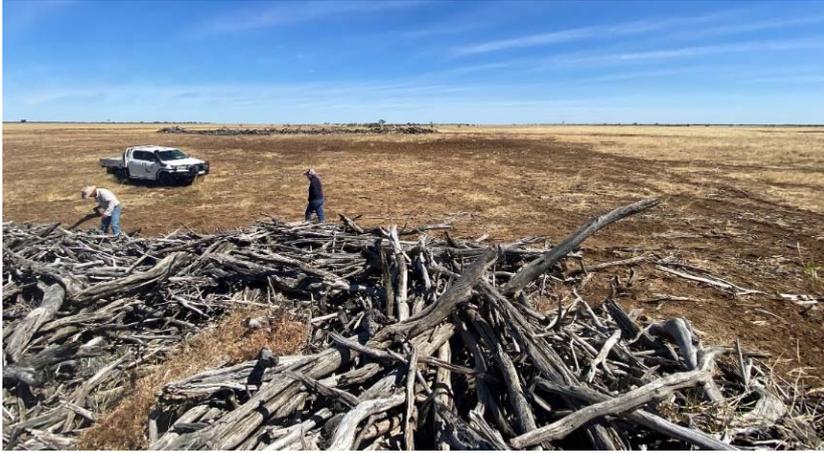
*Grass has started to recover on eroded areas, with tussocks also sprouting in the “beaver walls”.
(August 2021)*

Contour banks and flat bottom drains prevented further gully erosion. Rainfall (40 mm) in a short, sharp storm in early September 2021 indicated that the leaky barriers were effective in slowing the water. Ground cover has increased where the eroded gully has been battered and seeded. The decelerated pace of the water now allows for water infiltration into the soil, rather than just gushing across the surface. Intertwined throughout the log piles are tussocks that have sprouted. Annie added:
