Drought and climate adaptation program

Recovery, Restoration and Resilience in Mulga and Channel Country

A GrazingFutures Case Study

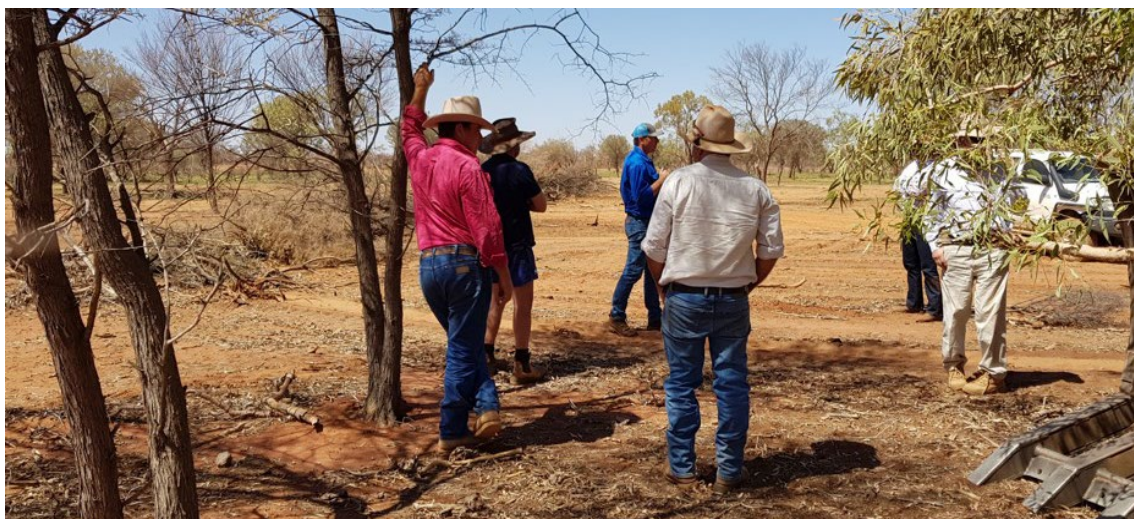
Figure 1: Local landholders pictured with Southern Queensland Landscapes representatives adjacent to timber weirs, 21/02/2020

Pictured above in Figure 1 is Southern Queensland Landscapes Project Officer Glenn Landsberg talking with local landholders about the timber weirs and their expected impact of the installation of the weirs. At this this time, the LCAT1 land score for the area was 10/100.

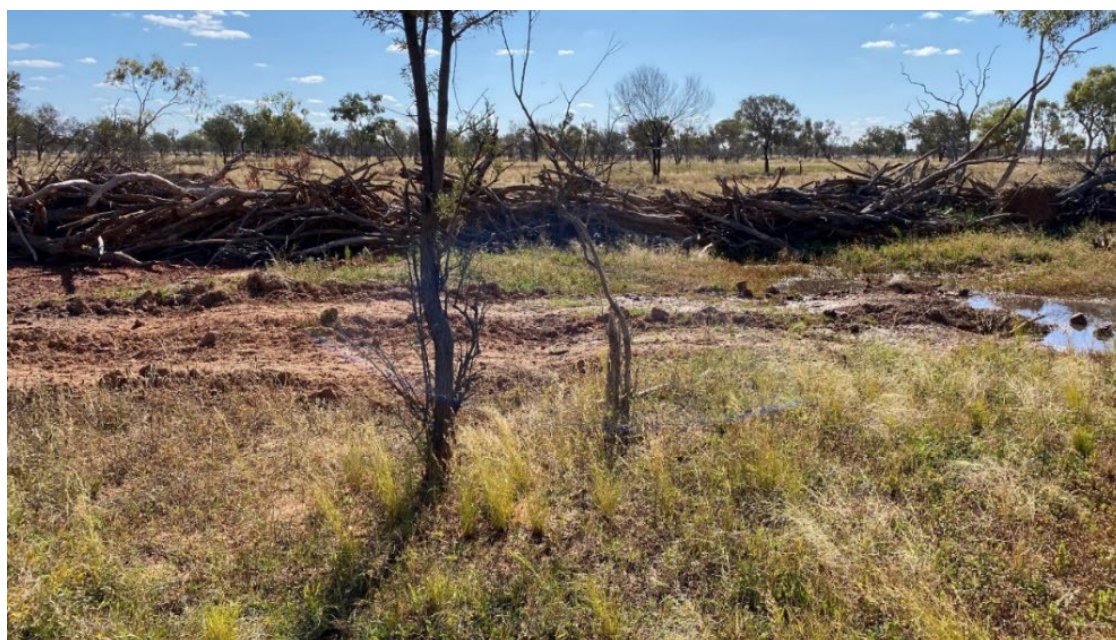
Figure 2: Timber weirs slowing the overland flow, 23/11/2020

As a comparison, following a few rain events, Figure 2 shows a section of the weir on the 23rd of November 2020. The impact of the weir is still relatively localised at this point in time but still has improved the area's LCAT land score, increasing it to 19/100. The land manager confirmed that the percentage cover of pasture in the area at this time was already notably higher than previously and persisted longer than pre-weir.

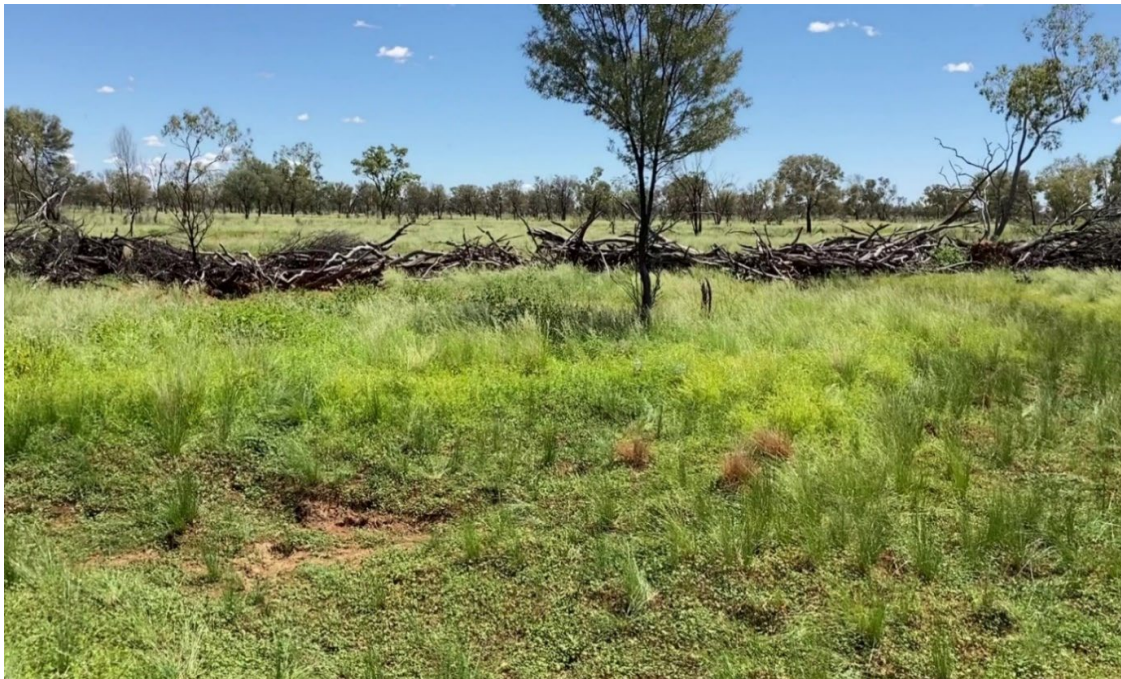
Figure 3 depicts the same section of weir in late February 2022, with a drastic increase in ground cover, compared to when first constructed. The benefits of the slowed overland flow are clear in this picture and have spread beyond the localised area. At this time the LCAT score had increased dramatically, measured at 94/100. The land manager also noted that in addition to the increase in pasture cover, pasture tended to persist longer following rainfall events when compared to pasture persistence prior to the installation of the weirs.

Figure 3: Pasture cover was demonstrably improved following the installation of the timber weirs, as seen in late February 2022

Following the installation of the weirs, the land manager estimated the water from heavier rainfall events persisted in the improved areas for over 48 hours, compared to the estimated 6 hours prior to the installation of the weirs. This slowing of the overland flow results in improved soil infiltration, reduced erosion, and improved pasture growth. As the landholder puts it “we’re going to be slower going into drought and getting out much quicker” due to being better able to retain and gain pasture with limited rain.
