GrazingFutures Case Study Spreader banks for water retention (Glenn Landsberg)

Enterprise details - Landsberg Family (Glenn) "Sunset" Charleville QLD 4470

Description of the management/practice change

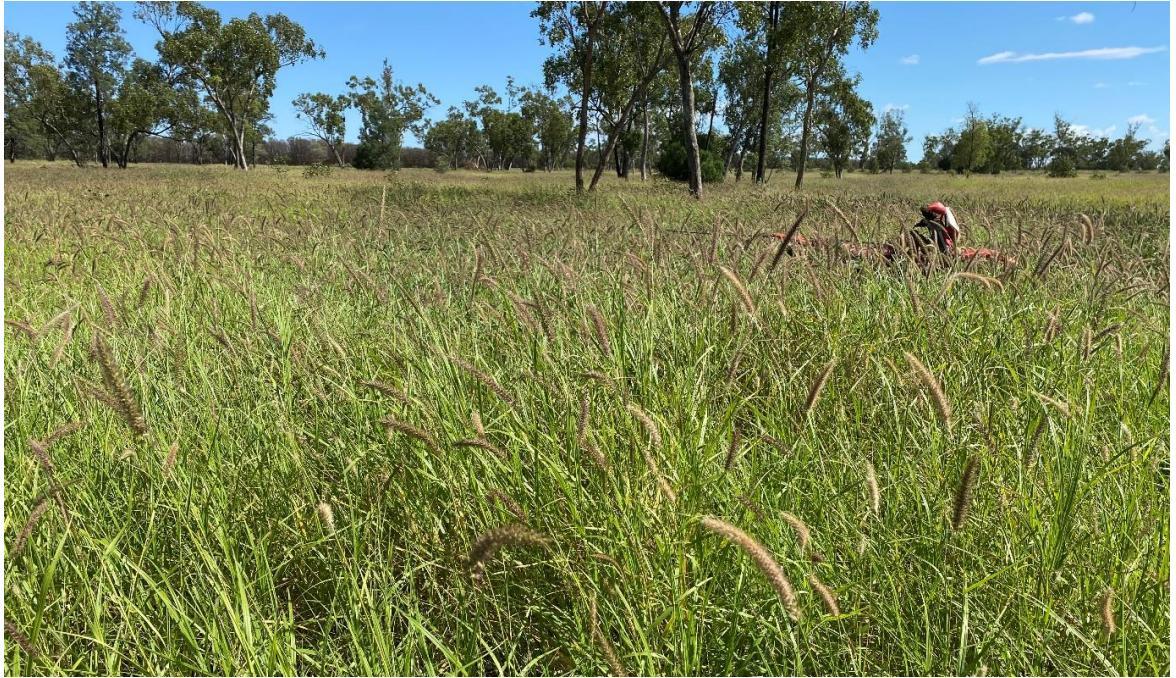
Figure 1: Pasture in Site A is very thick and healthy around old spreader banks.

Site A - At the oldest site with two original banks installed in 2015 Glenn could push a rod down 90-120cm. Pastures were well established at this site (Appendix; Figures 1 and 2).

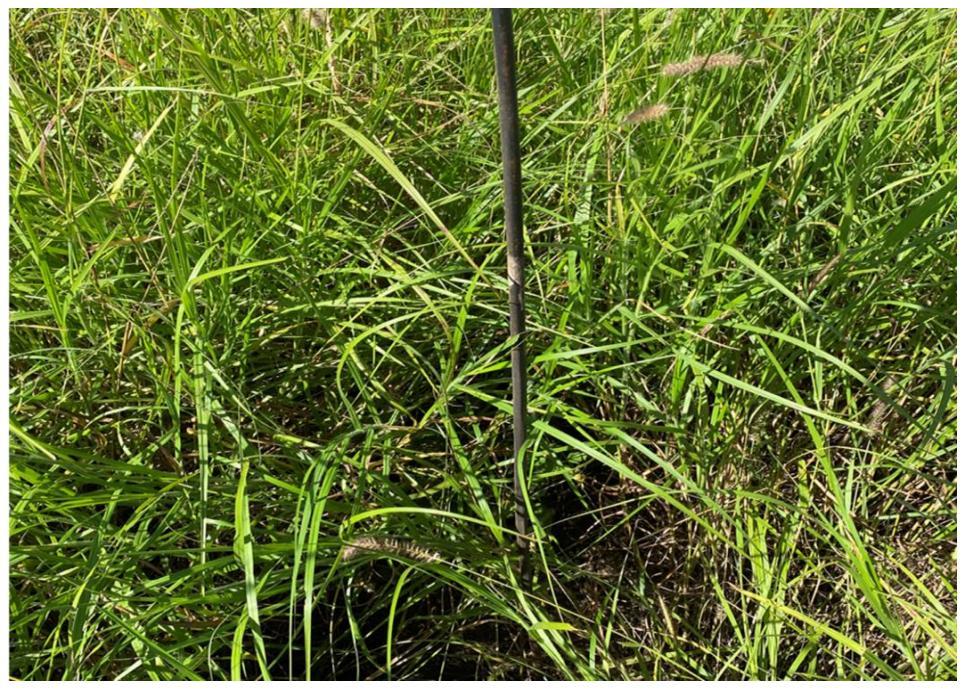
Figure 2: (Site A) Moisture probe still going down 90-120cm around old established spreader banks 26 March 2020.

'This area must have great root systems established as pasture held on and remained productive right through the drought.

The older banks in Site A were a different design to the new banks I have created after attending the Avondale field day. Except at road crossings, they are all under 30cm. The main trench is on the uphill side and they are designed to spread water flow over a large area and water gently flows <u>over</u> the banks. My soil sets very hard so water trickling over the length of the whole bank has not caused any damage once they were settled. If I'd made them higher, I'm sure they would have eroded. They are now very stable with pasture. With the exception of road crossings, the banks have been maintenance free for 5 years.

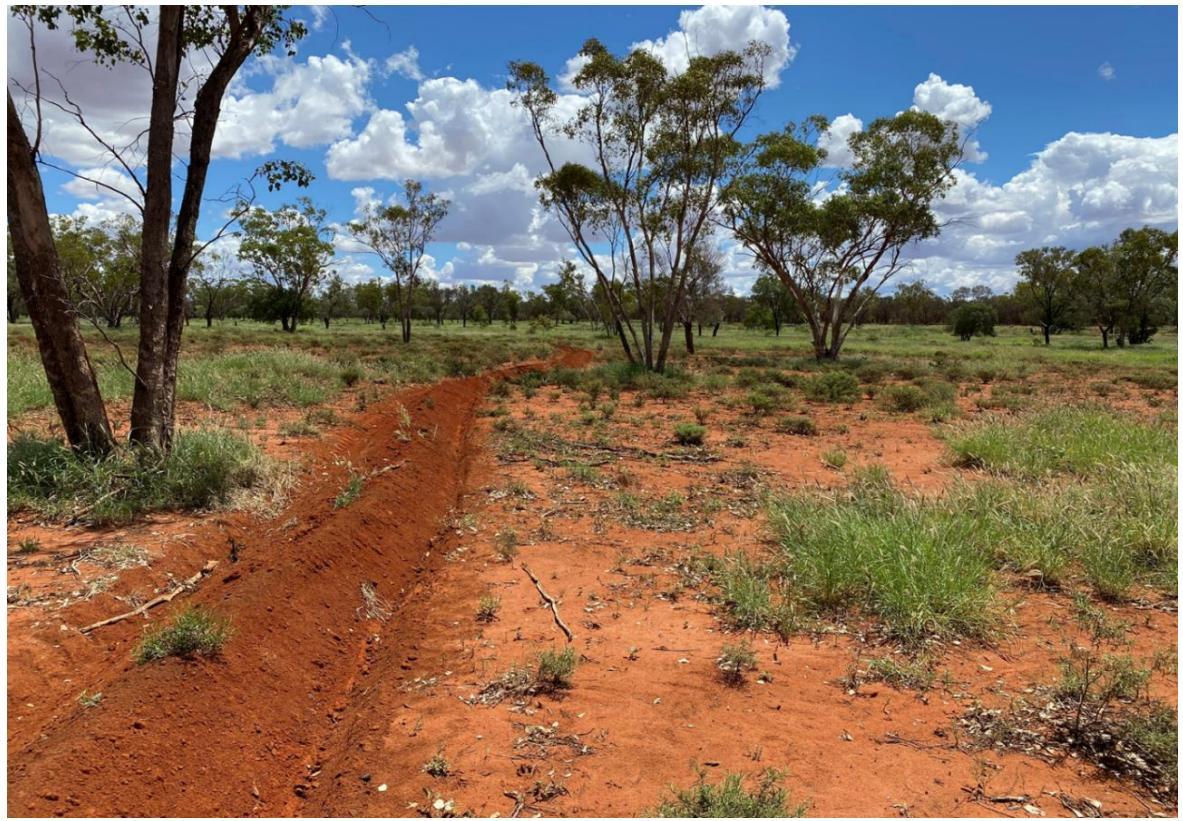
Figure 3: (Site B) Installing new banks on 14 February 2020 in country that had received 160mm in January.

These banks included two cuts with an angled blade with the loose dirt forming the ridge in the middle. The top of the dirt is approximately 50-40cm and since the rain, this has settled down to approximately 30cm. The banks that settled less than 30cm or were built in the harder areas, where my machine couldn't form the bank, failed in the big storm and needed repairs.

This is why Ray Thompson suggests its ideal to make the banks 100cm high to allow for settling. Banks were built using 3 passes each side with the bottom pass being most important to get correct.

Site B - In the area where Glenn constructed five new banks closer together, a technique learnt at the field day, he could push the rod down 70-90cm with ease in bare areas that were previously rock hard (Appendix; Figures 3, 4, 5 and 6).

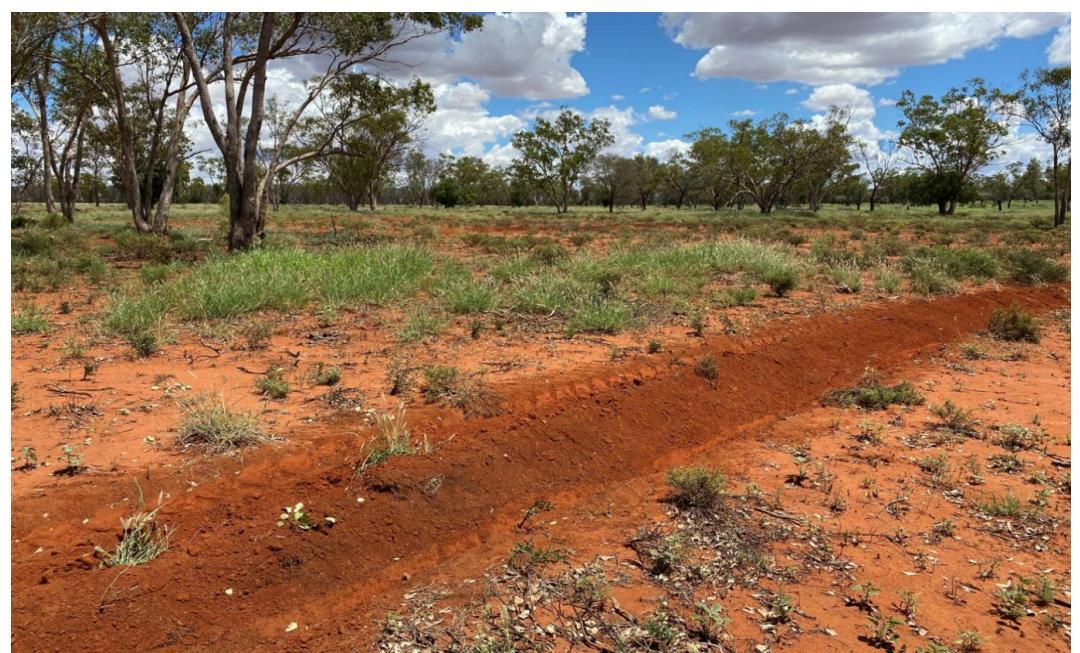
Figure 4: Five shallow spreader banks up the side of a slope made with the blade on the back of a small tractor. It is critically important to be spot on with levels when banks are so low.

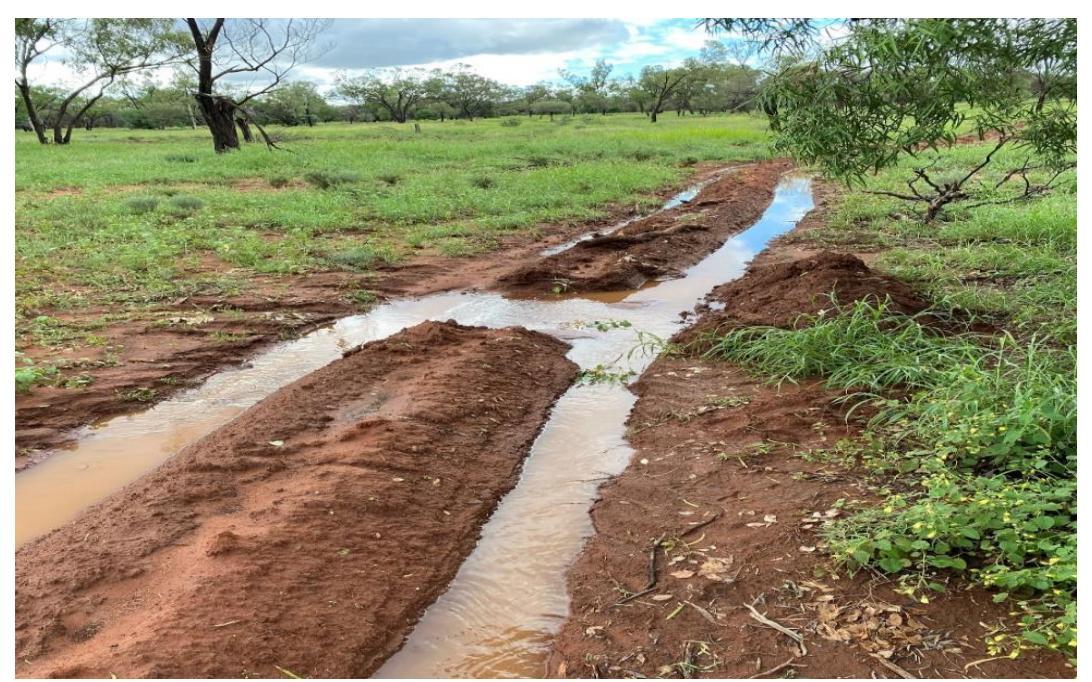
Figure 5: (Site B) Bank failure following 160mm of rain at the end of February and then 107mm in early March 2020.

Six hours after the last of the rain, water was still spreading and slowing as it meandered through the maze of banks.

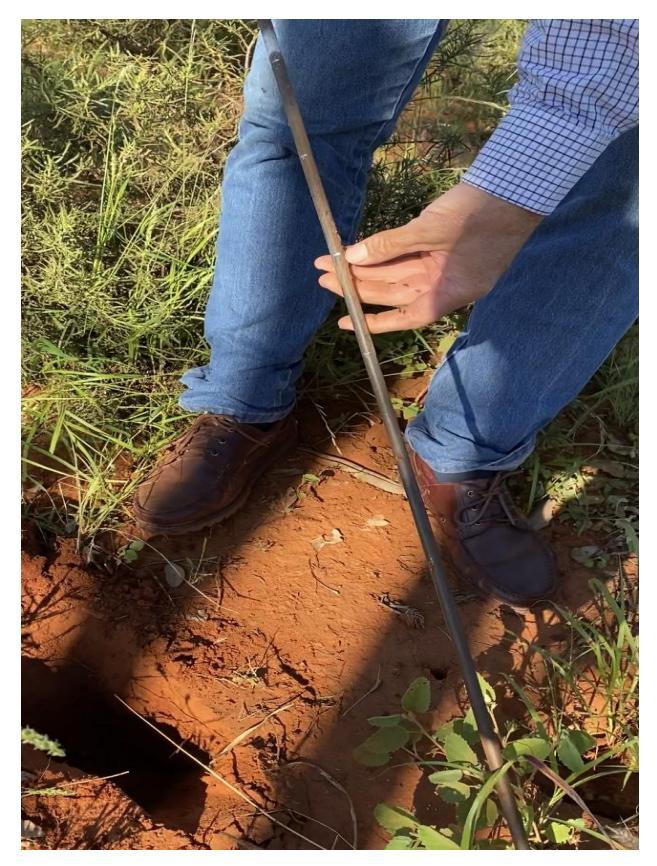
Figure 6: (Site B) Soil moisture probe 19 March 2020, 10 days after rain.

Figure 6 shows the soil moisture probe still going down 70-90cm 10 days post rain anywhere in the paddock where the new spreader banks had been installed.

Any bare ground is still soft and moist to dig. Pasture is going to grow for a long time yet, there may be enough stored moisture for grass to green up again after winter. This had been some of the least productive country before installing new spreader banks. By spreading out and slowing the water coming off the main road this area has the potential to be some of the most productive. I'm quite confident the new design will outperform the old spreader banks.

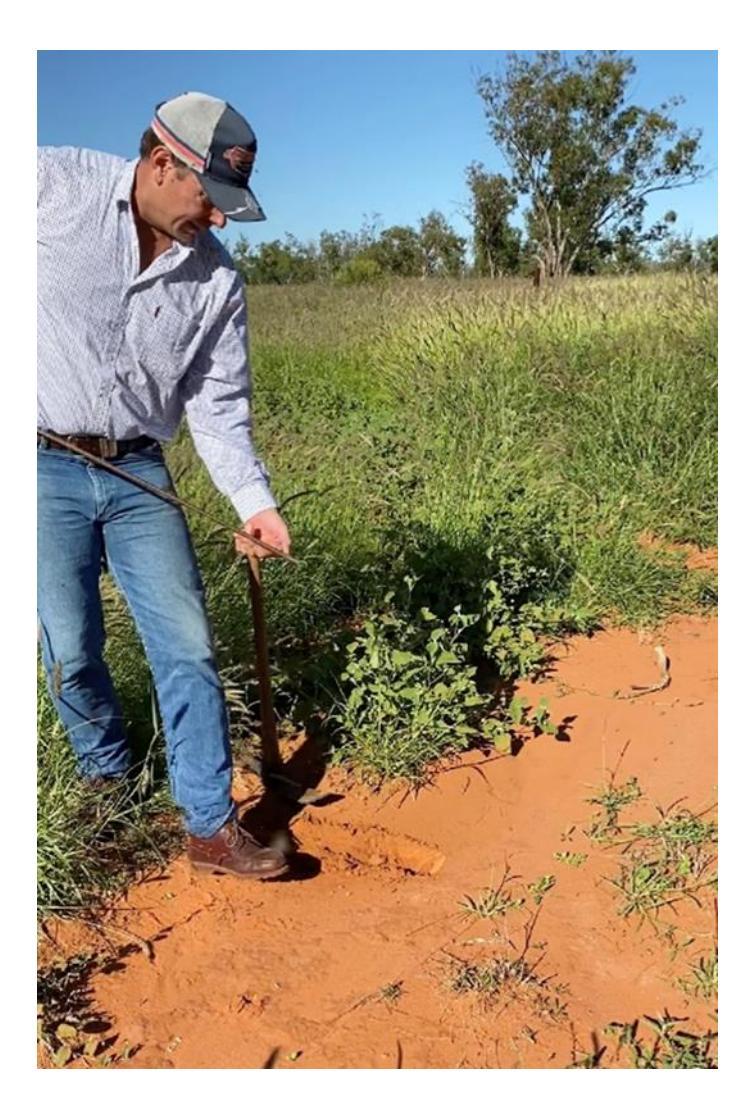
Figure 7: Site C, the next paddock over had the same rainfall but no spreader banks have been installed.

Couldn't get the rod more than 5cm into bare ground. No sign of moisture when digging on bare ground, water ran off too quickly 19 March 2020.

Do you have a bit of 10mm rod in the scrap heap at home? Simple easy way to test your soil moisture and future grass growing potential.'

Site C - In the control paddock without banks, under similar rainfall conditions, Glenn said he was unable to push the rod in more than 5cm (Appendix; Figure 7).

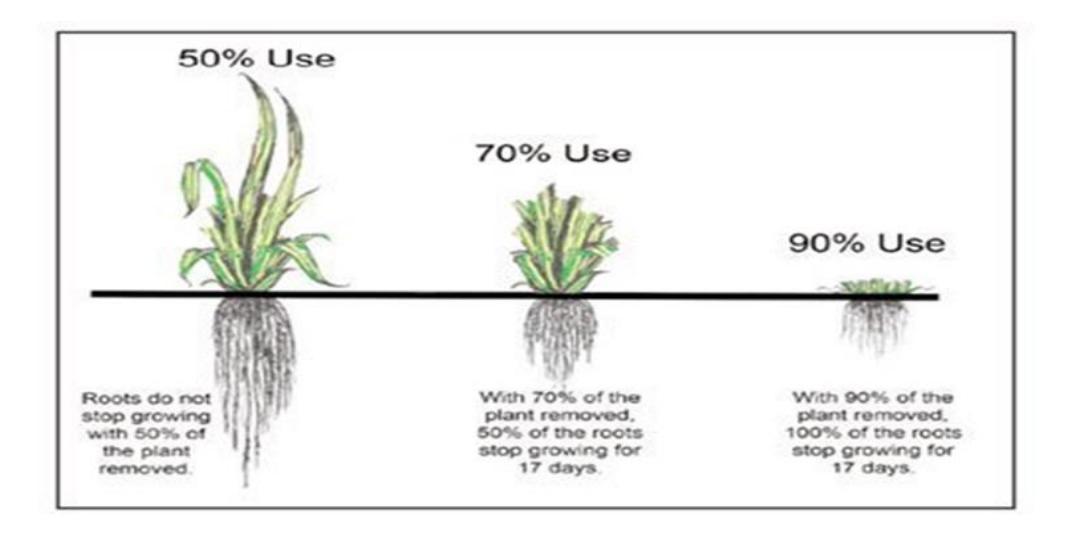
Figure 8: Great "Grass Farmers" Grow Roots (Kathy Voth 2015)

The more bulk above ground, the bigger the root system (Appendix; Figure 8) \rightarrow the deeper the root zone of pasture the deeper water can infiltrate \rightarrow leads to a greater soil moisture/water storage bank \rightarrow leads directly to how long pasture continues to grow or survive after a rain event. This is very relevant during the drought when we often only had one rain event for the year.

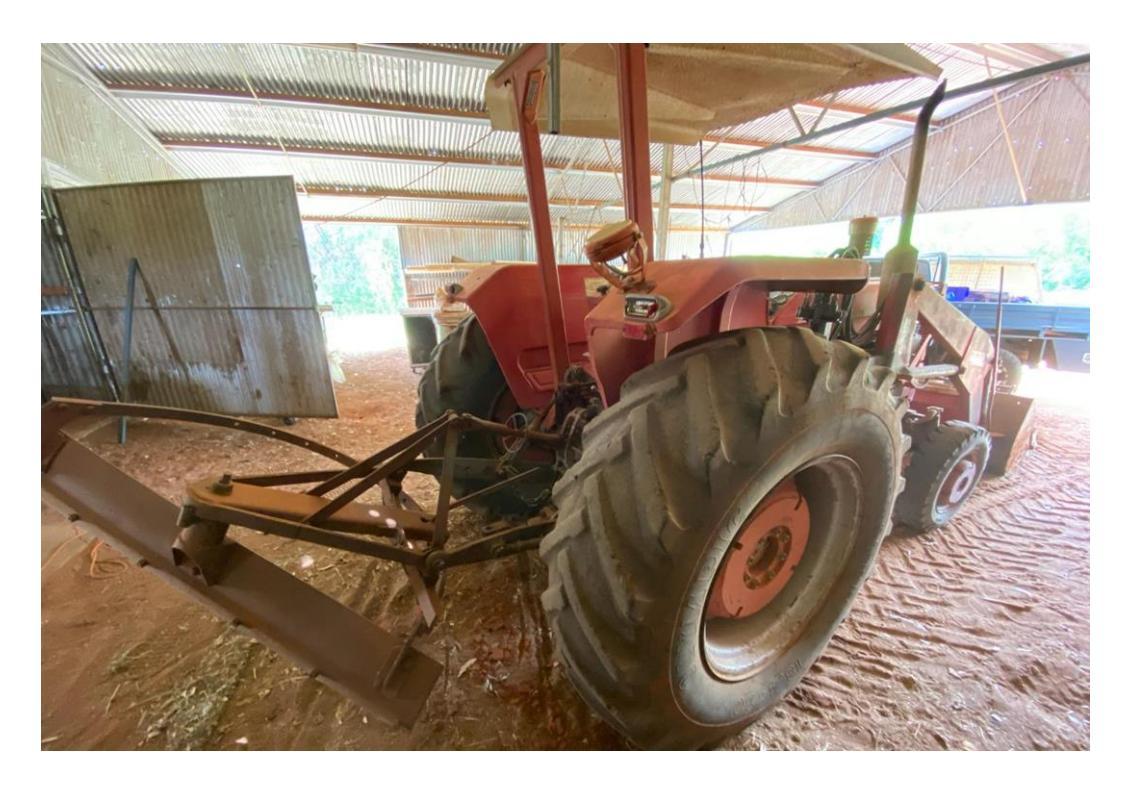
Figure 9: The 67hp tractor with set up with a 3-point linkage grader blade used to make the banks.

"I only have a 67hp tractor with a 3 point linkage grader blade set up (Appendix; Figure 9). Which required 3 passes on each side. So, someone with a bigger machine could potentially build the same sort of banks as mine in two passes very cheaply.
